2019 Calendar Year Surveillance Review
Tailings Dam 1
Aeris Tritton Mine

Tritton Resources Pty Ltd
PER2019-0430AB rev0

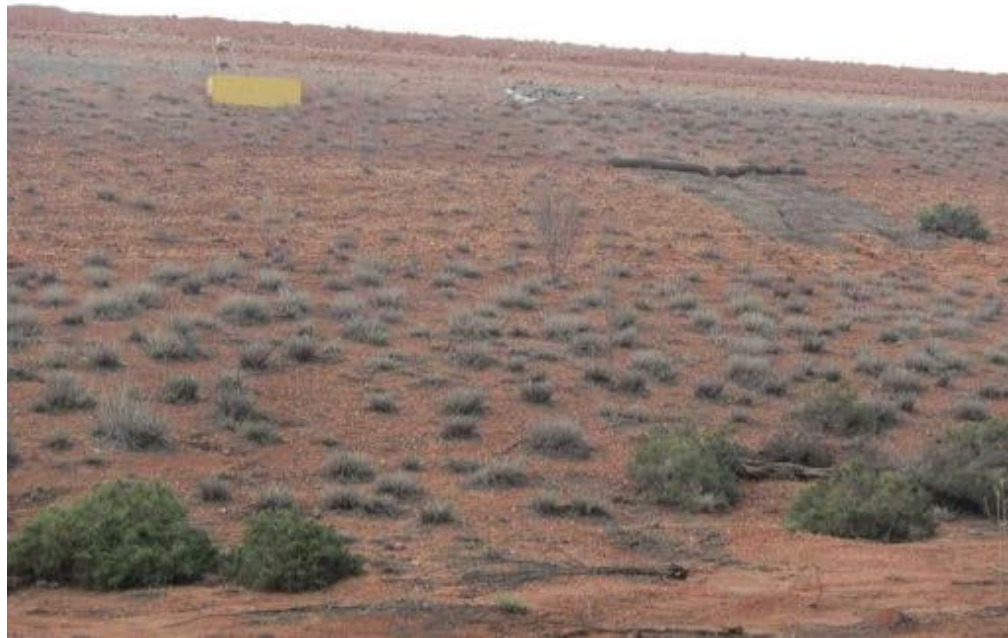
Main embankment batter slope with erosion protection, coir matting.

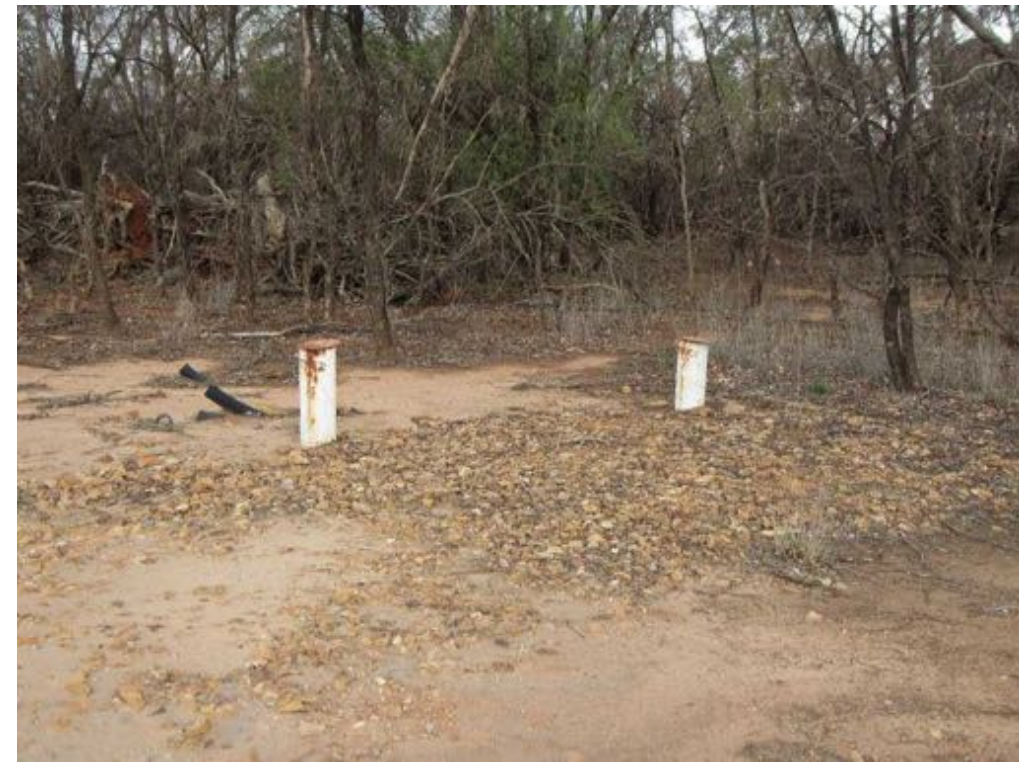
PZH002D and S suite of bores downstream of main embankment.

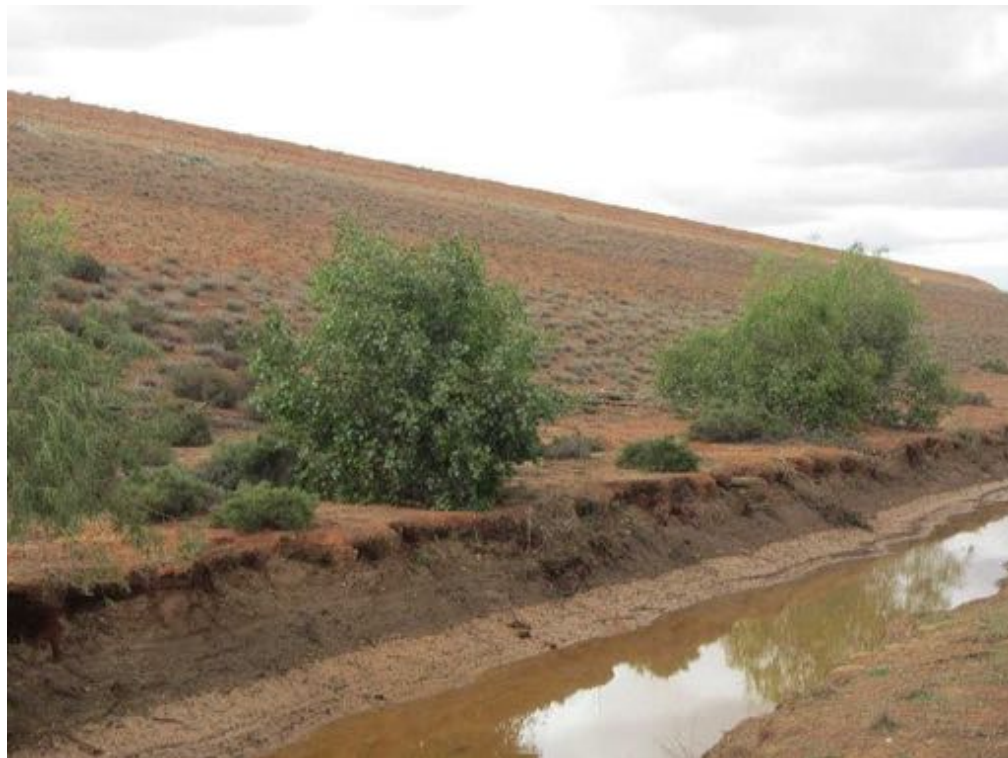
No trees should be allowed to become established on the embankments, as root penetration can occur and this should be monitored while the facility is active. No trees were noted on the embankment, several were noted in the downstream toe drain. The small trees located in the downstream toe area were removed in early 2018 but some have re-established mainly in or near the toe drain and currently do not compromise the embankment (refer to Figure A1).

Small trees downstream of main embankment, not distressed.

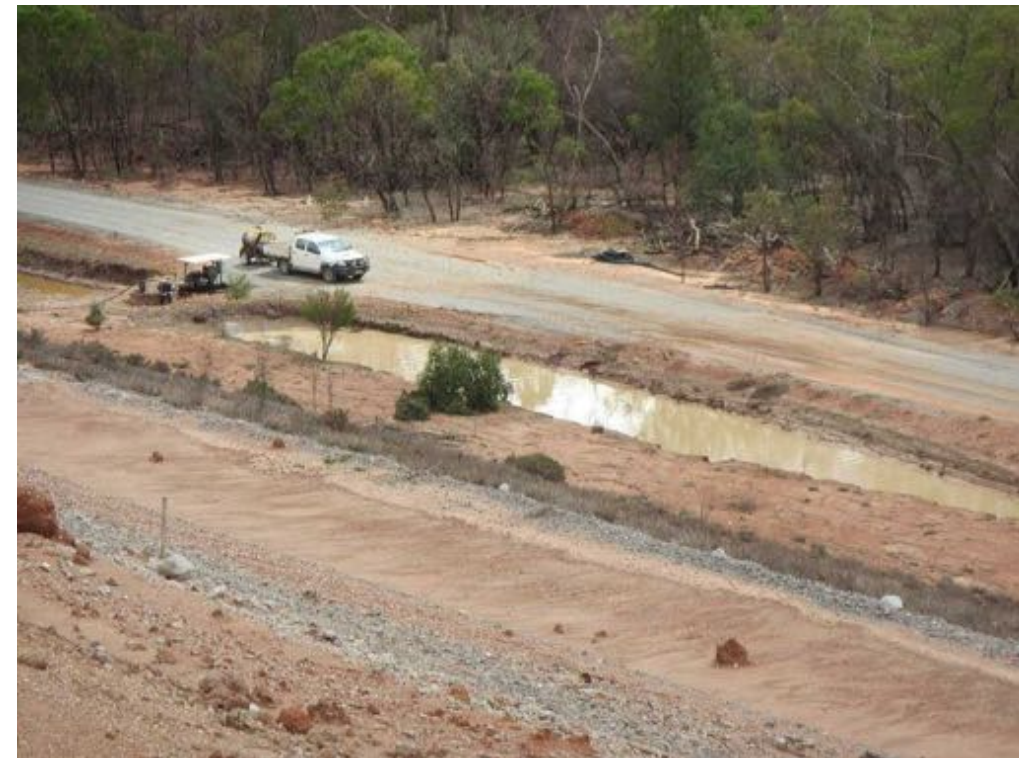
View of downstream sump. Recent rain in toe drains.

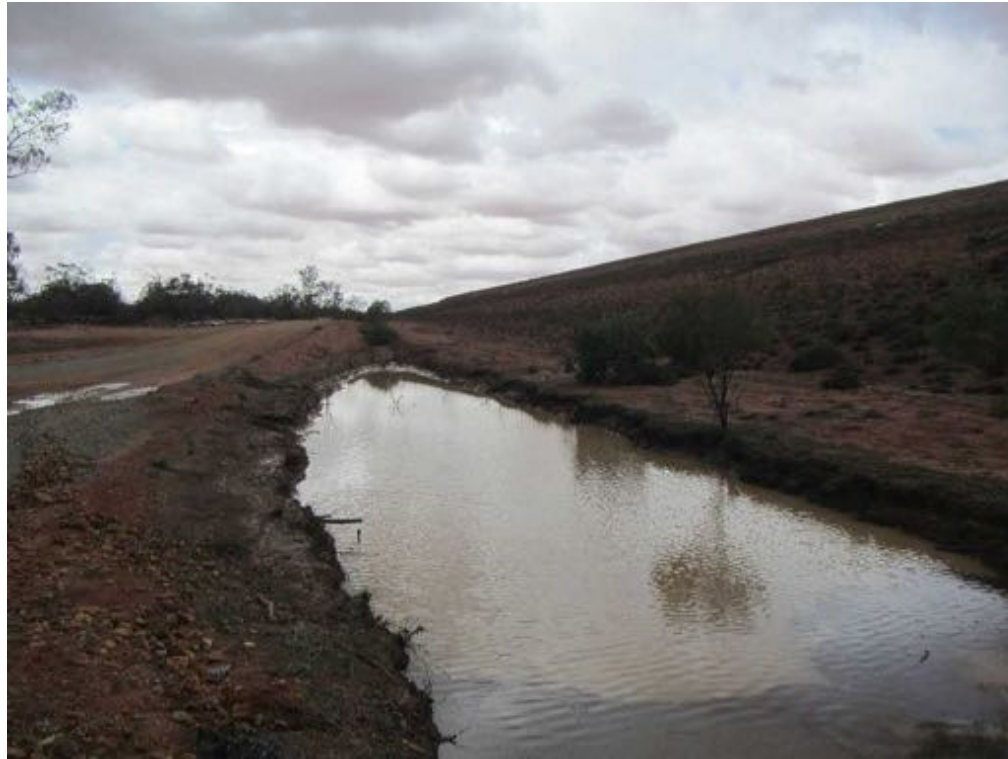
Downstream batter slope main embankment and downstream toe drain looking south.

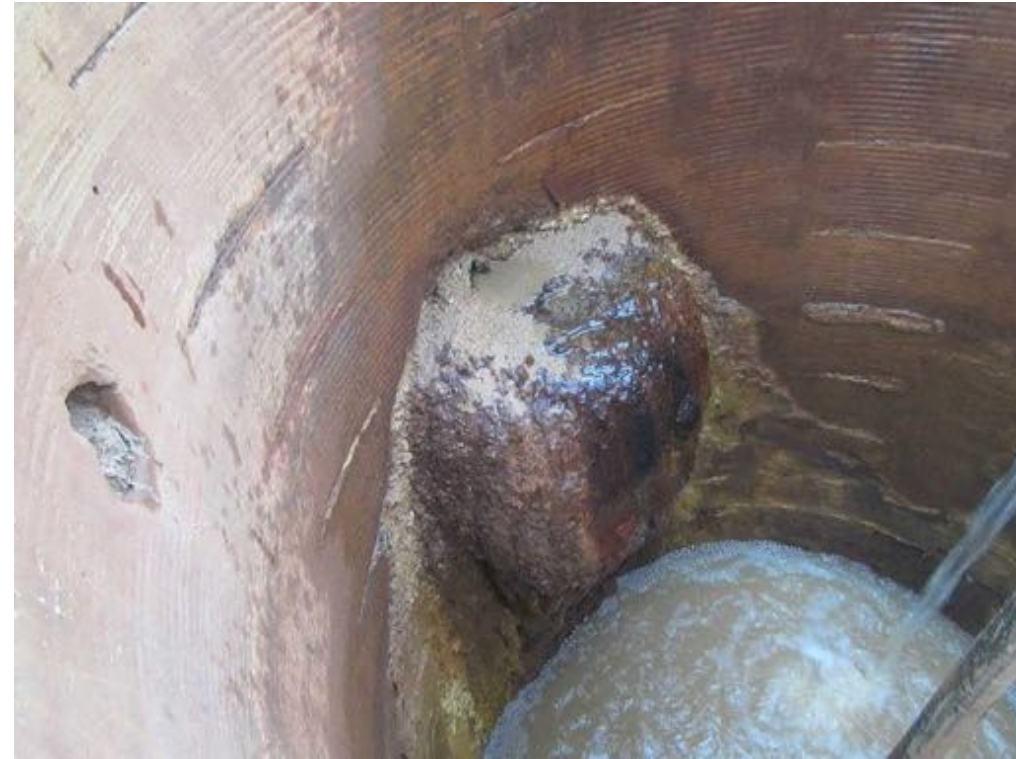
It was observed that the underdrainage pipe was still discharging a trickle of water into the concrete sump even after 15 years of operation.

Underdrainage recovery sump still receiving underdrainage flow after 15 years of operation.

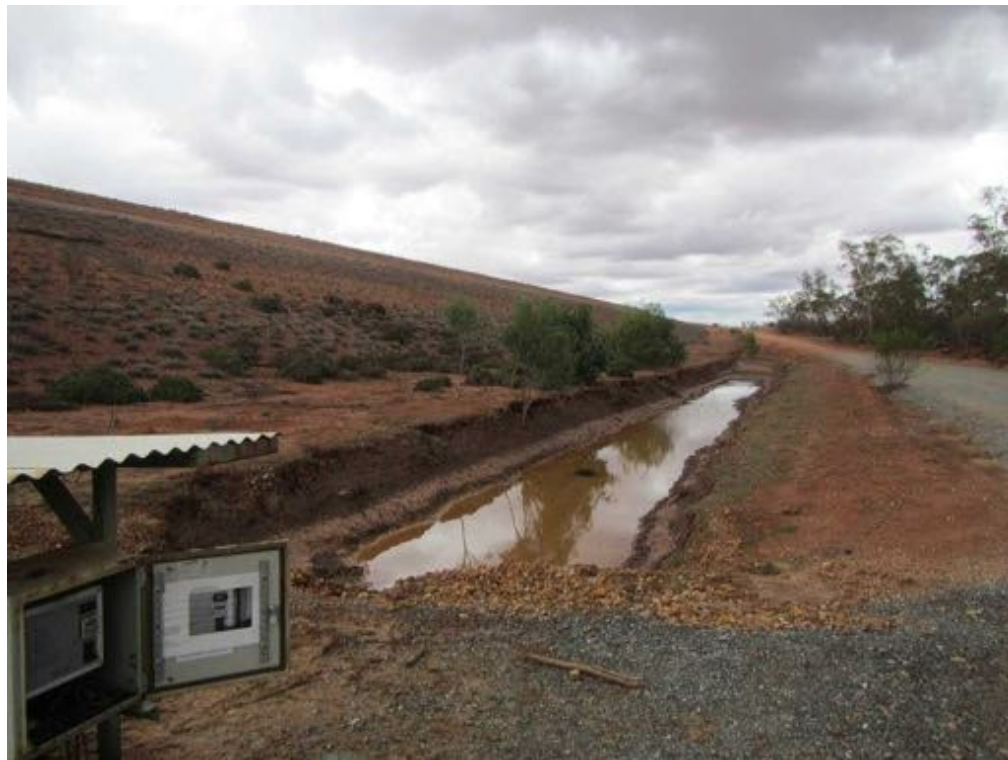
Downstream batter slope main embankment and downstream toe drain looking north.

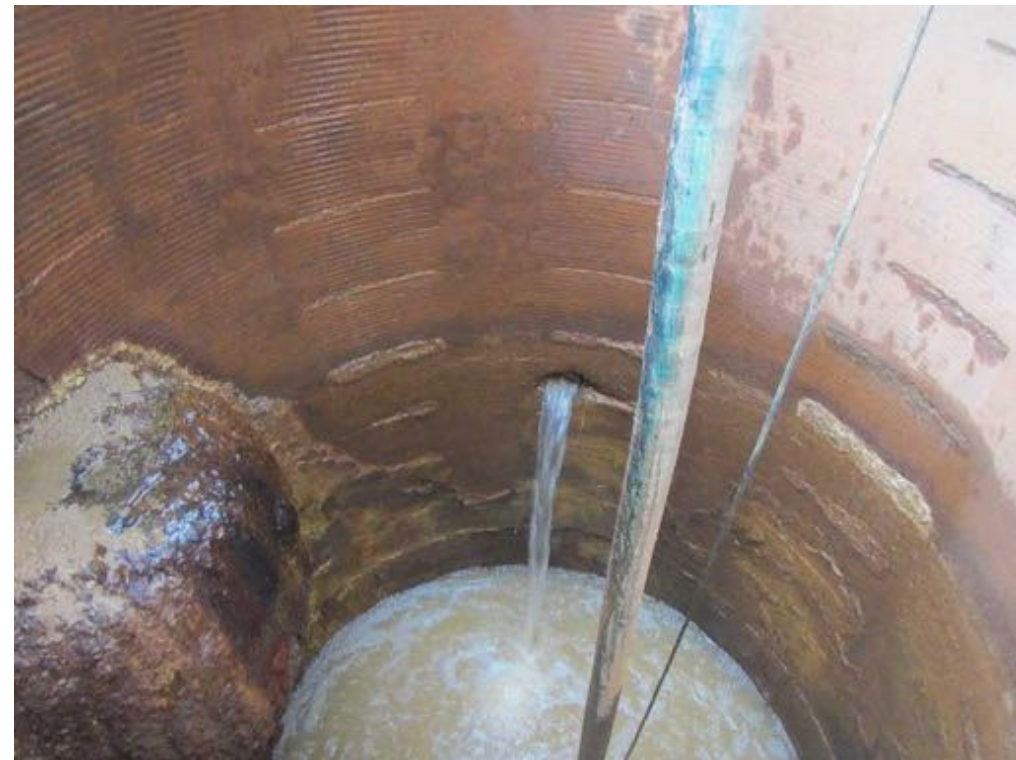
Sump receiving toe drain water southern side and underdrainage inflow.

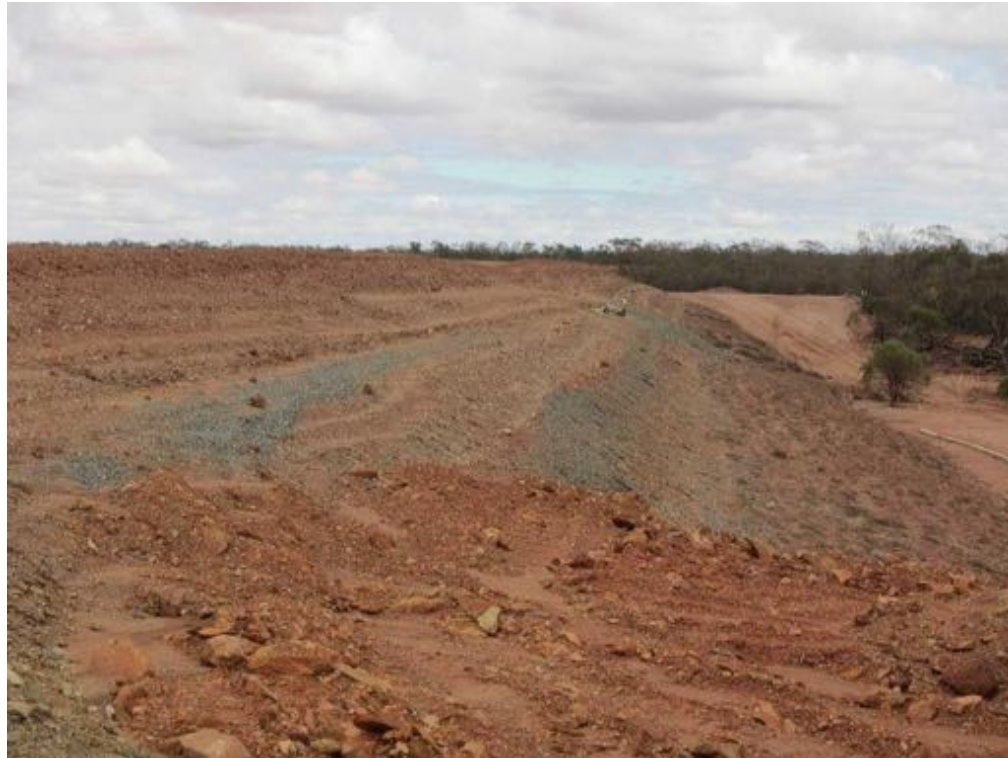
Northern embankment looking towards spillway area.

It is recommended that when Stage 7 works are undertaken, the spillway and northern embankment are raised last to ensure the spillway is operational if required. It should be noted that under correct operating conditions (which has been the case for the last 15 years) there is a very low risk that the spillway will ever be used due to a high or extreme rainfall event.

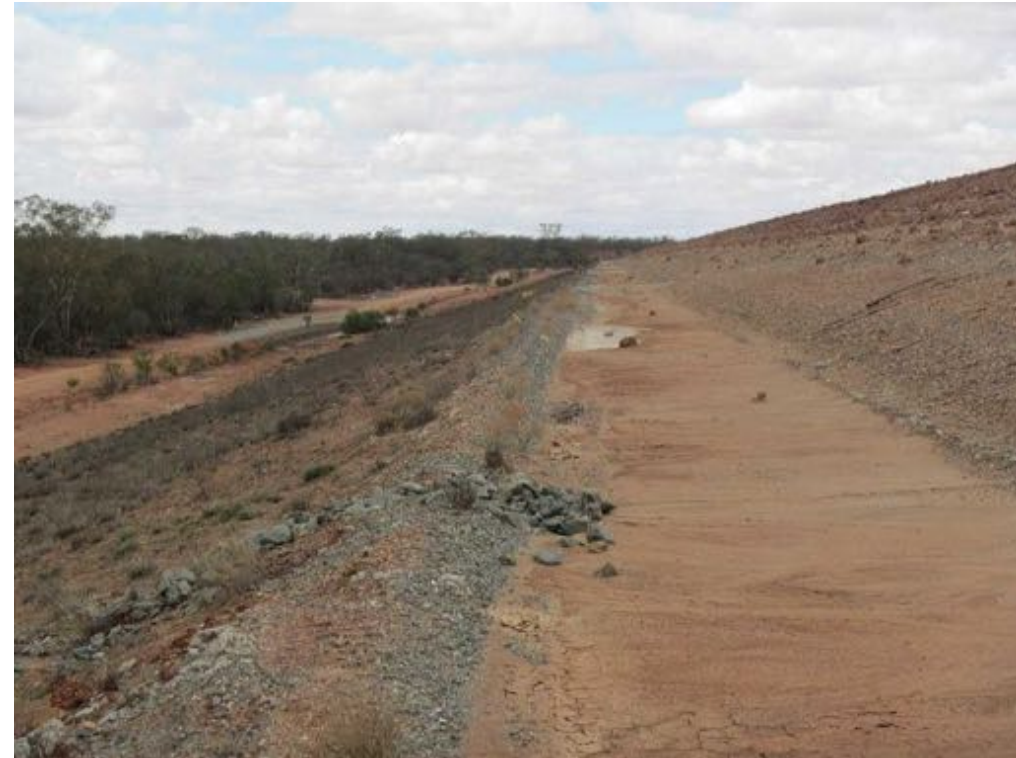
The intermediate berm was visually assessed to be sloping outwards, there are now numerous breaks in the edge windrow to allow rainfall discharge. The breaks coincide with previous scour locations which have now been treated by way of cutting out, geofabric placement and backfilled with small rocks. It was assessed that the minor erosion scars observed currently do not affect the overall integrity of the embankment. At several locations, evidence of small piping 'holes' were observed where water has accumulated against the downstream edge windrow. One pipe was observed to exist at the base of the slope and this area needs to be treated, as discussed with Jamie while on site. The piping voids are currently only minor and do not pose an overall safety or stability issue for the embankment.

Intermediate berm main embankment looking south.

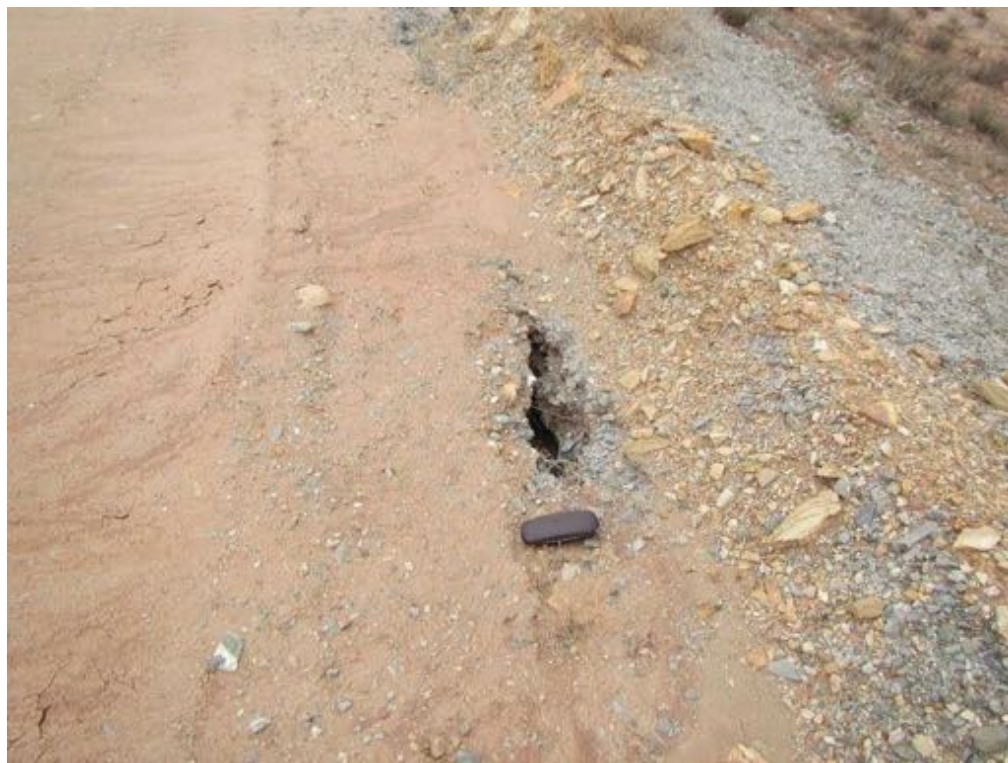
Piping crack northern end of intermediate berm, .

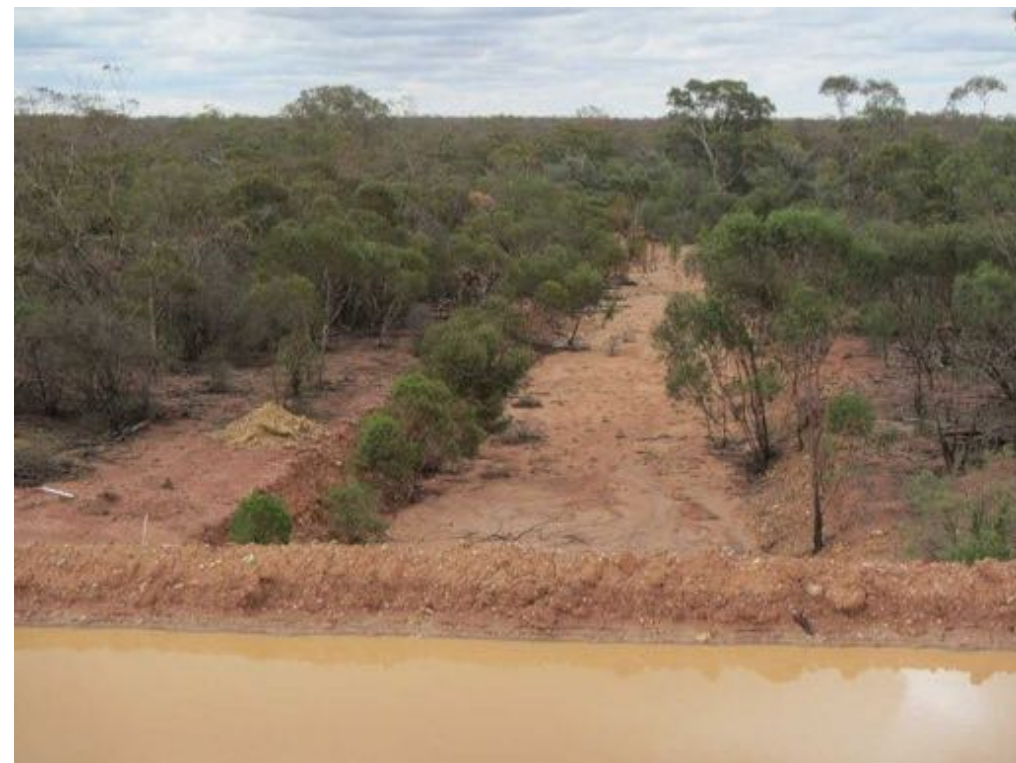
View along spillway channel. Recent rain on embankment.

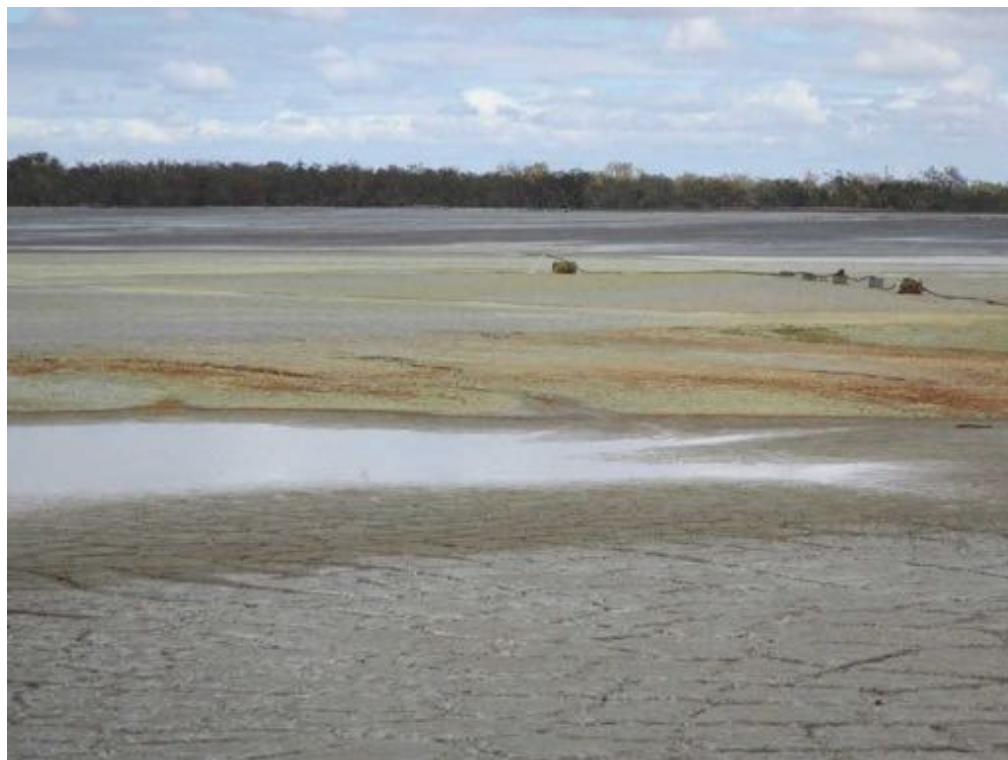
Downstream sump water discharge well out onto tailings beach.

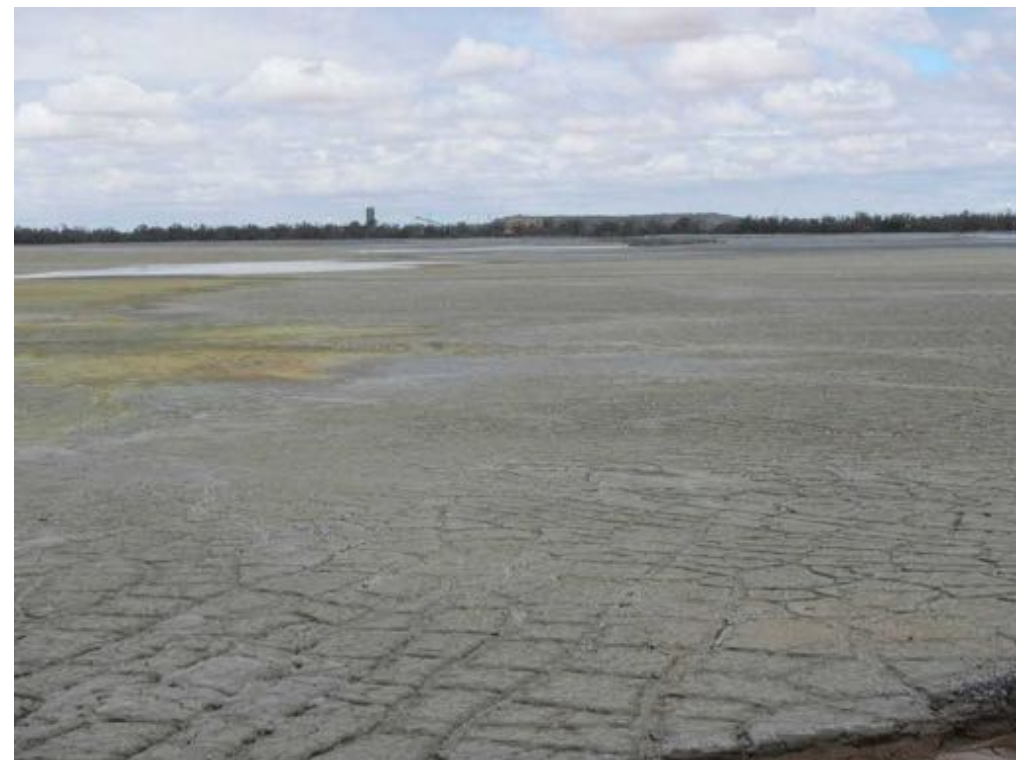
A very small water pond was present on the tailings dam surface, Figure A6. No water was being recovered at the time of the visit due to the drought conditions. The pond was located away from any perimeter embankments due to the steeply sloped tailings beaches and preferential deposition from the saddle embankments. Some water (rainfall) was located in an excavation next to the main embankment, it was instructed for this area to be infilled with tailings which will be undertaken when sequencing allows deposition.

Looking across tailings dam from main embankment showing small decant pond.

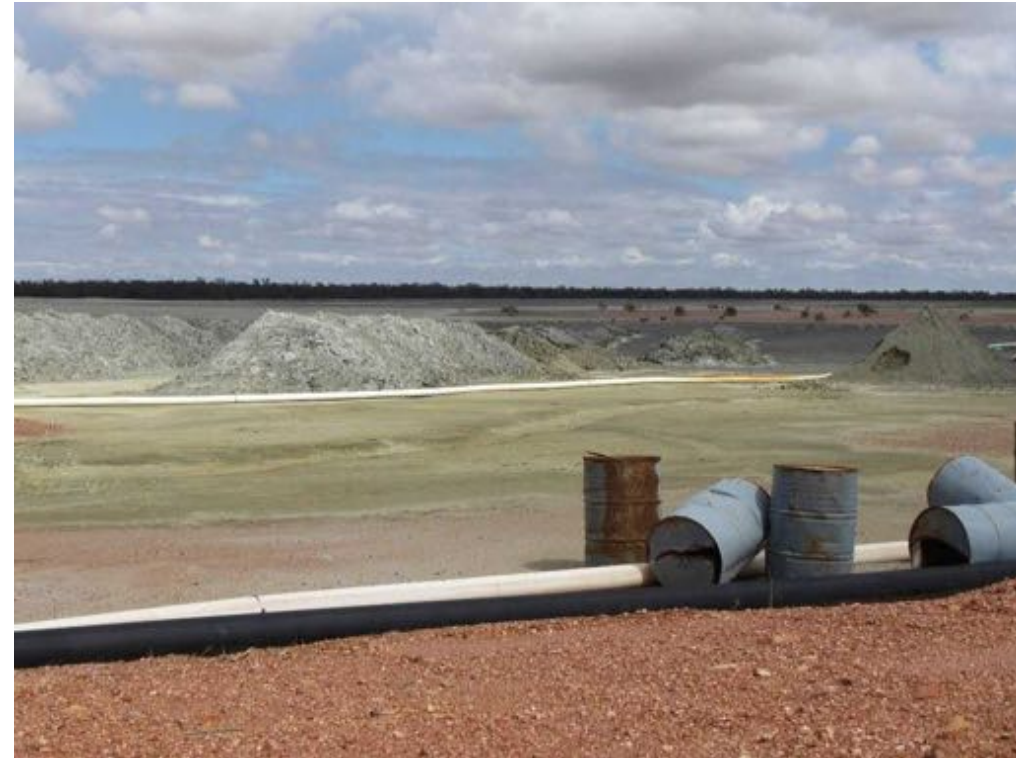
Stockpile of old tailings for backfill trial (did not proceed).

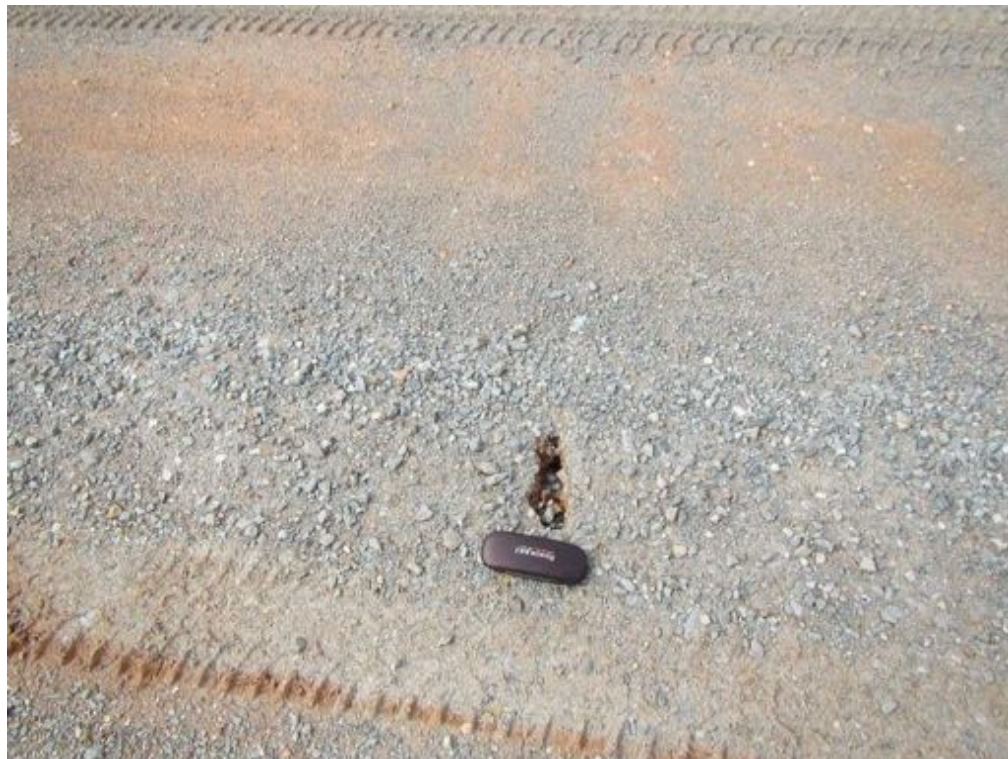
Small crack in western embankment (yet to be raised).
