# 2022 Annual Review

# Tritton Copper Mine

Period: 1 January 2022 to 31 December 2022

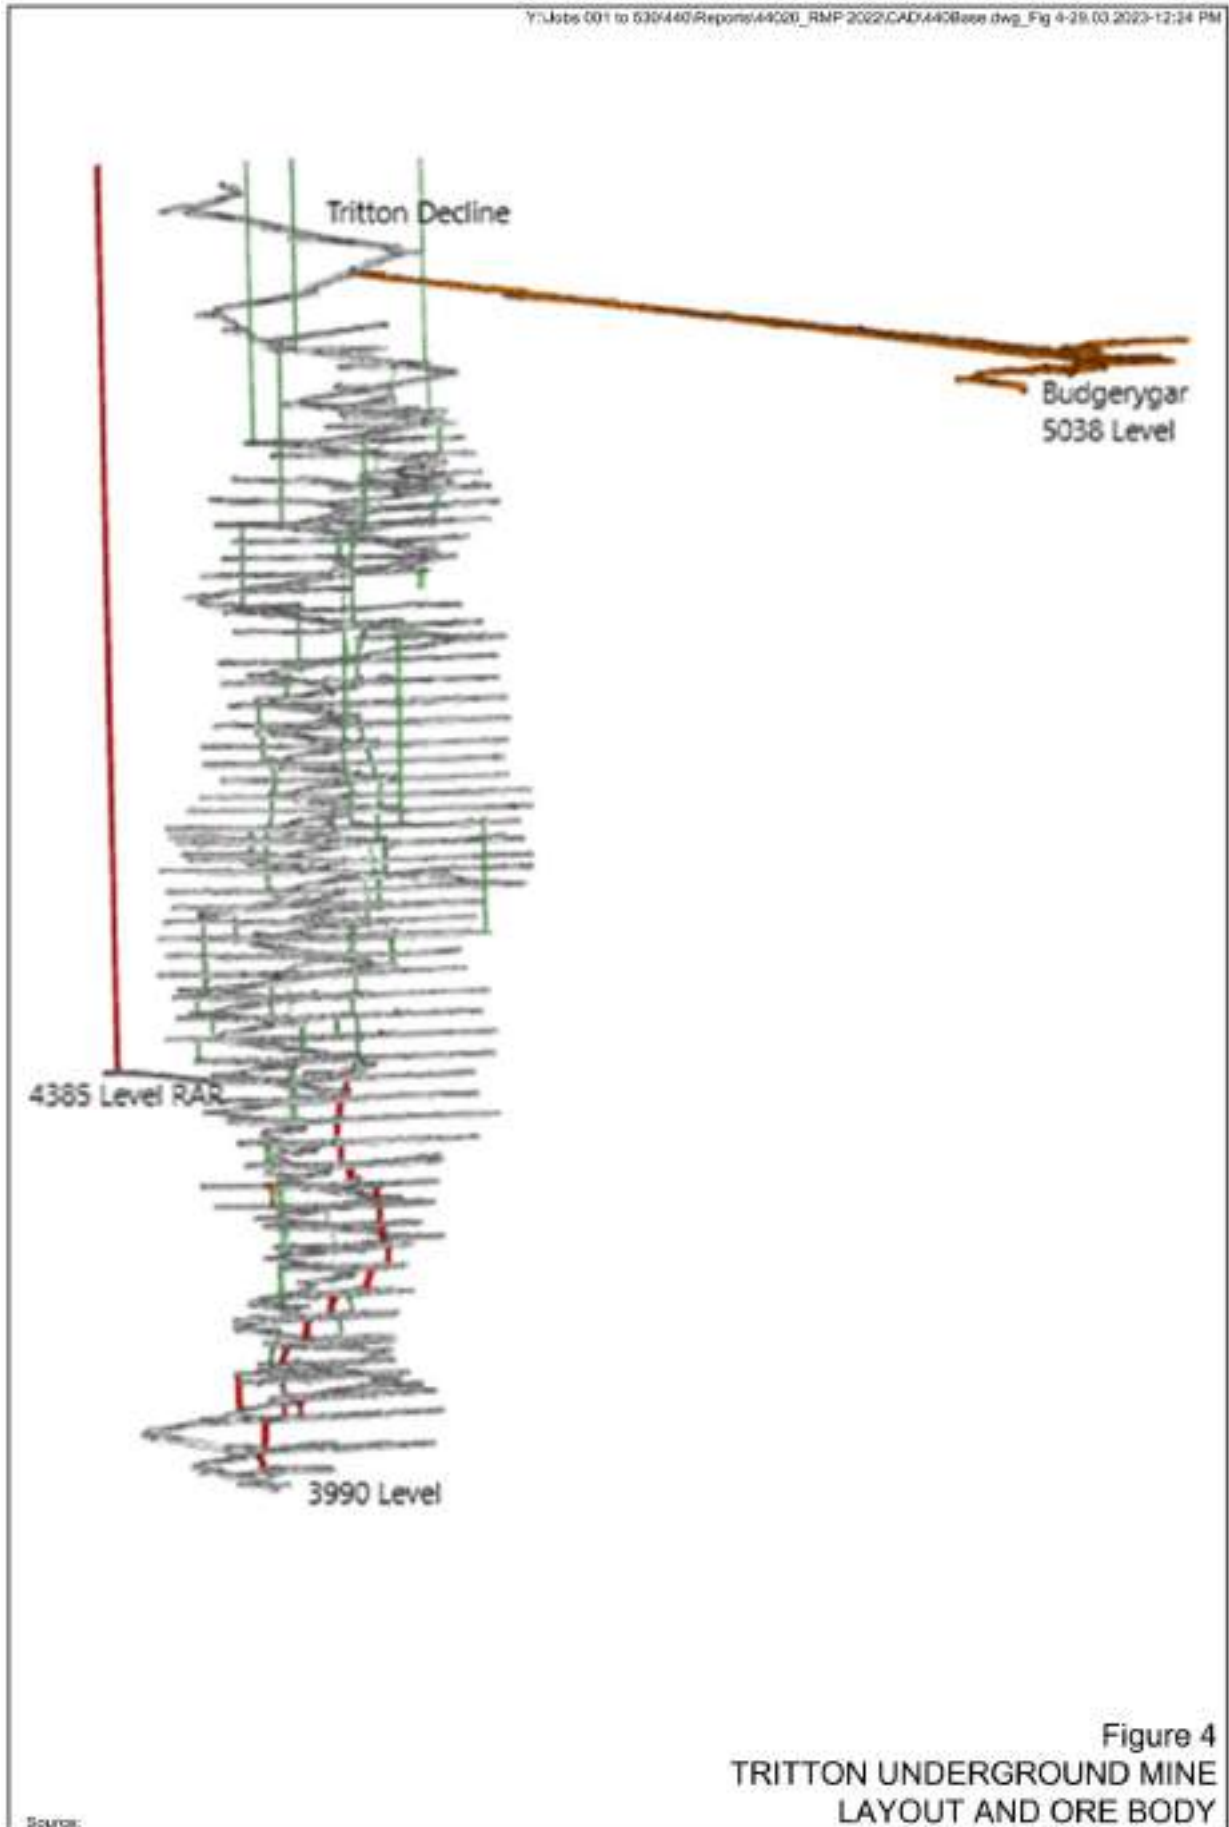
The current underground mine layout is shown in **Figure 4**.

During this reporting period there was 2,925m of development undertaken in the Tritton underground mine. This development was in the form of 1,917m of capital development, 1,008m of operating development (ore and waste). In addition, 247m paste dig and stripping was undertaken & 261m of vertical development. Of the 202,345t of waste rock produced from this development, 110,403t was used underground as backfill and the remainder (91,942t) trucked to the surface waste rock emplacement. At the end of December 2022, the deepest part of the mine was RL 3990 m, which places it approximately 1,280m below the surface.

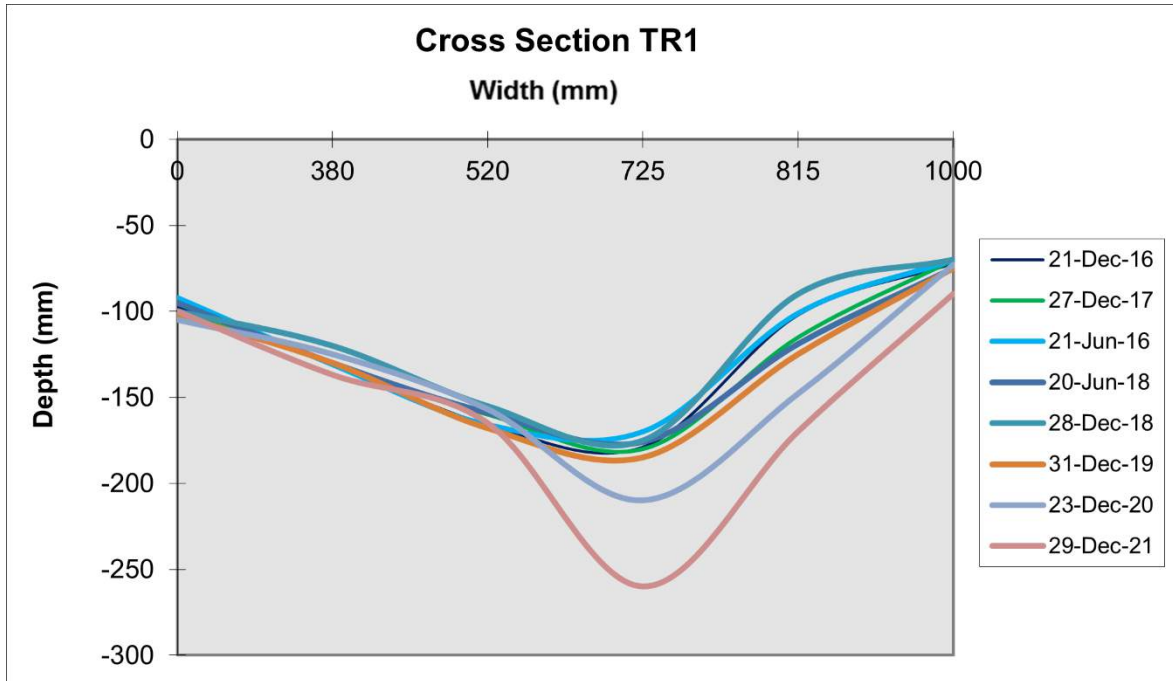
Graph 1 EROSTR001

Erosion and sediment control monitoring conducted during 2022 was primarily concerned with the TSF embankment wall rehabilitation areas. Tritton have established three transect dimension monitoring points, two on the TSF embankment wall and one on an analogue site within the mine lease. Cross sections of each of the monitoring points are provided in Cross Section Graphs 1-3.

The depth and width data at EROSTR001 and EROSTR002 is consistent with the previous reporting period. The analogue site results are stable, the most significant change being a decrease in depth of 10mm. EROSTR001 saw no changes in depth of more than 5mm. The most significant change at EROSTR002 was an increase in depth of 10mm. The results are in line with the expectations of less than 30% change.
