2019 Calendar Year Surveillance Review
Tailings Dam 1
Aeris Tritton Mine

Tritton Resources Pty Ltd
PER2019-0430AB rev0

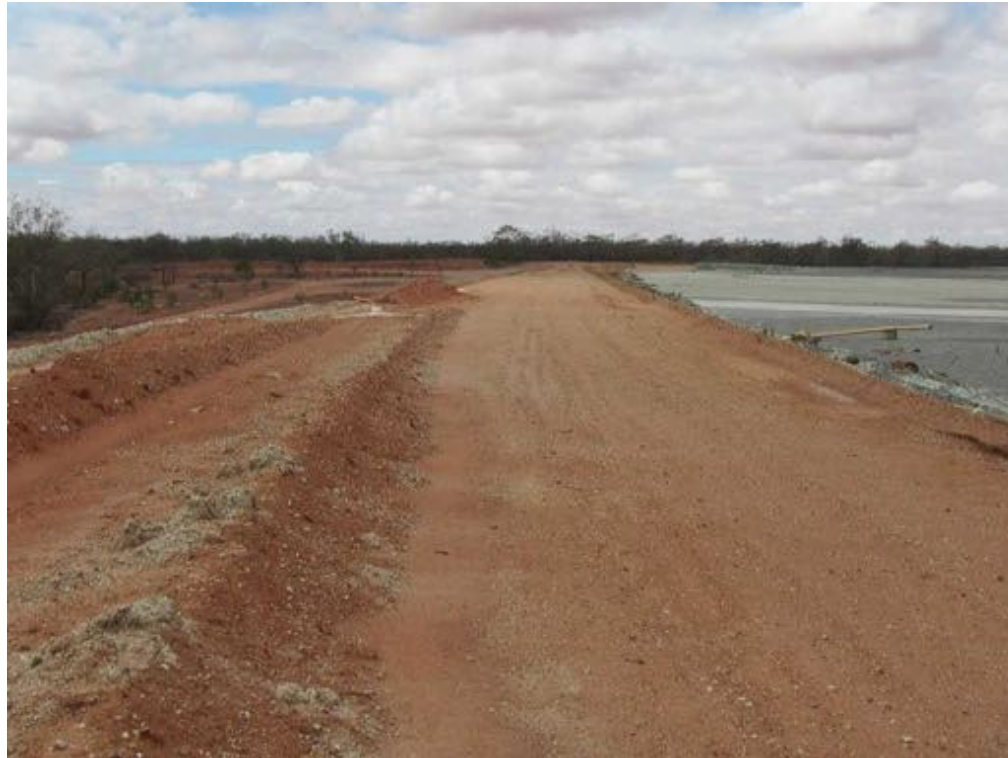
Main embankment looking south.

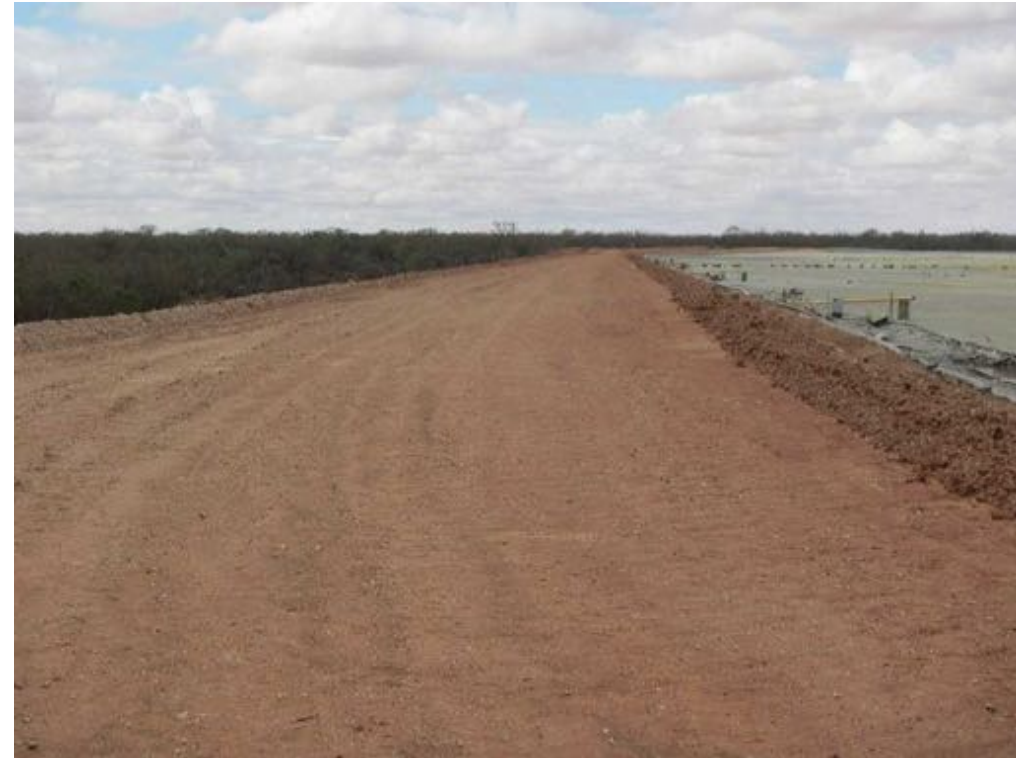
Looking south along main embankment crest.

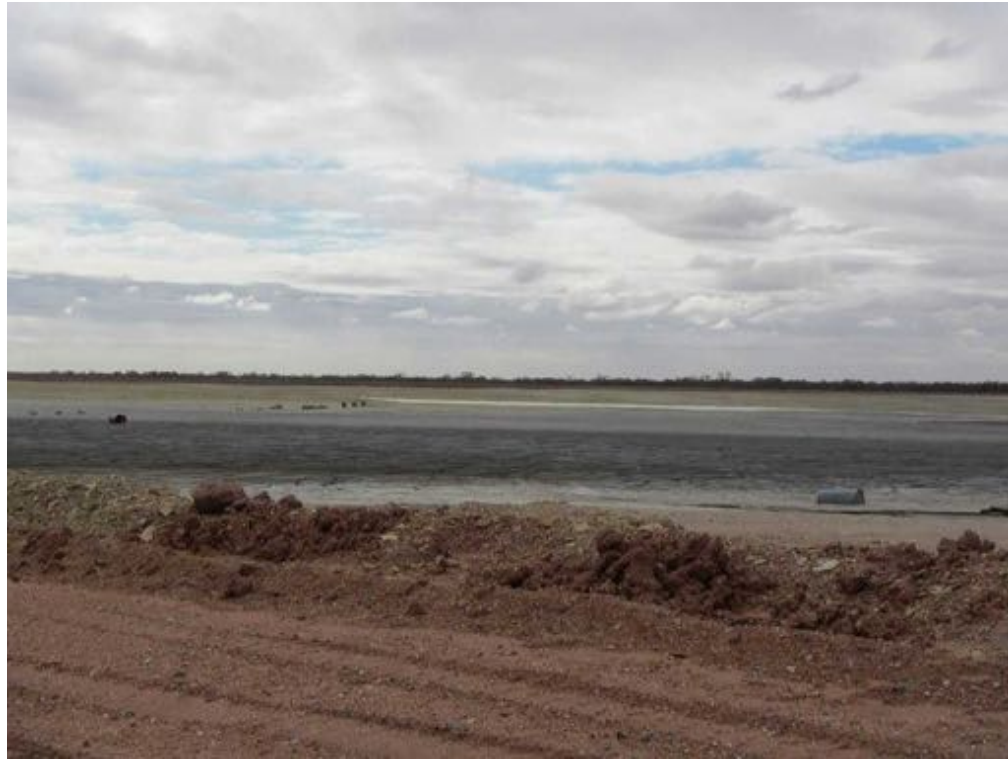
Looking east over tailings dam.

- Any rainfall runoff collected behind the western saddle embankment should be monitored, the temporary use of this area as a source of construction water is considered acceptable in the short term. The embankment crest should be monitored (visually) for any signs of distress in the way of cracking or slumping. Of note the mine has placed a berm along the downstream toe to prevent water ponding against the original embankment toe.

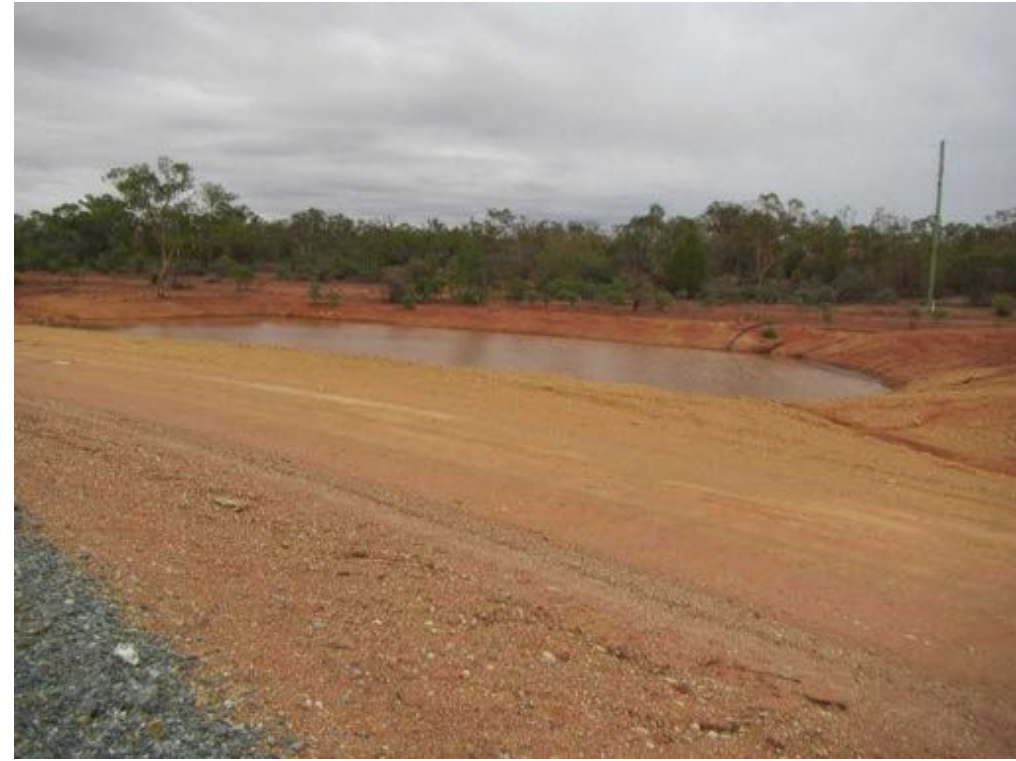
Sump downstream of western embankment used for construction purposes.

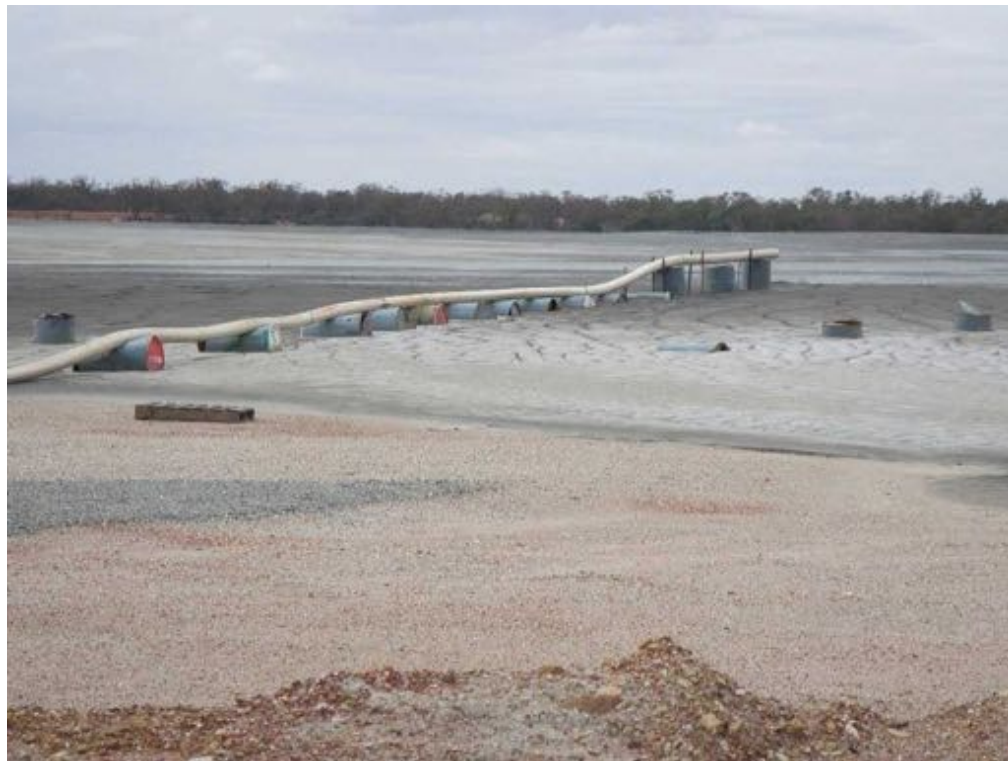
Extended spigot pipes supported on drums.
