**2022 Calendar Year Annual Review and
Safety Standards Report
Tailings Dam 1
Aeris Tritton Mine**

Tritton Resources Pty Ltd
PER2022-0315AB rev0

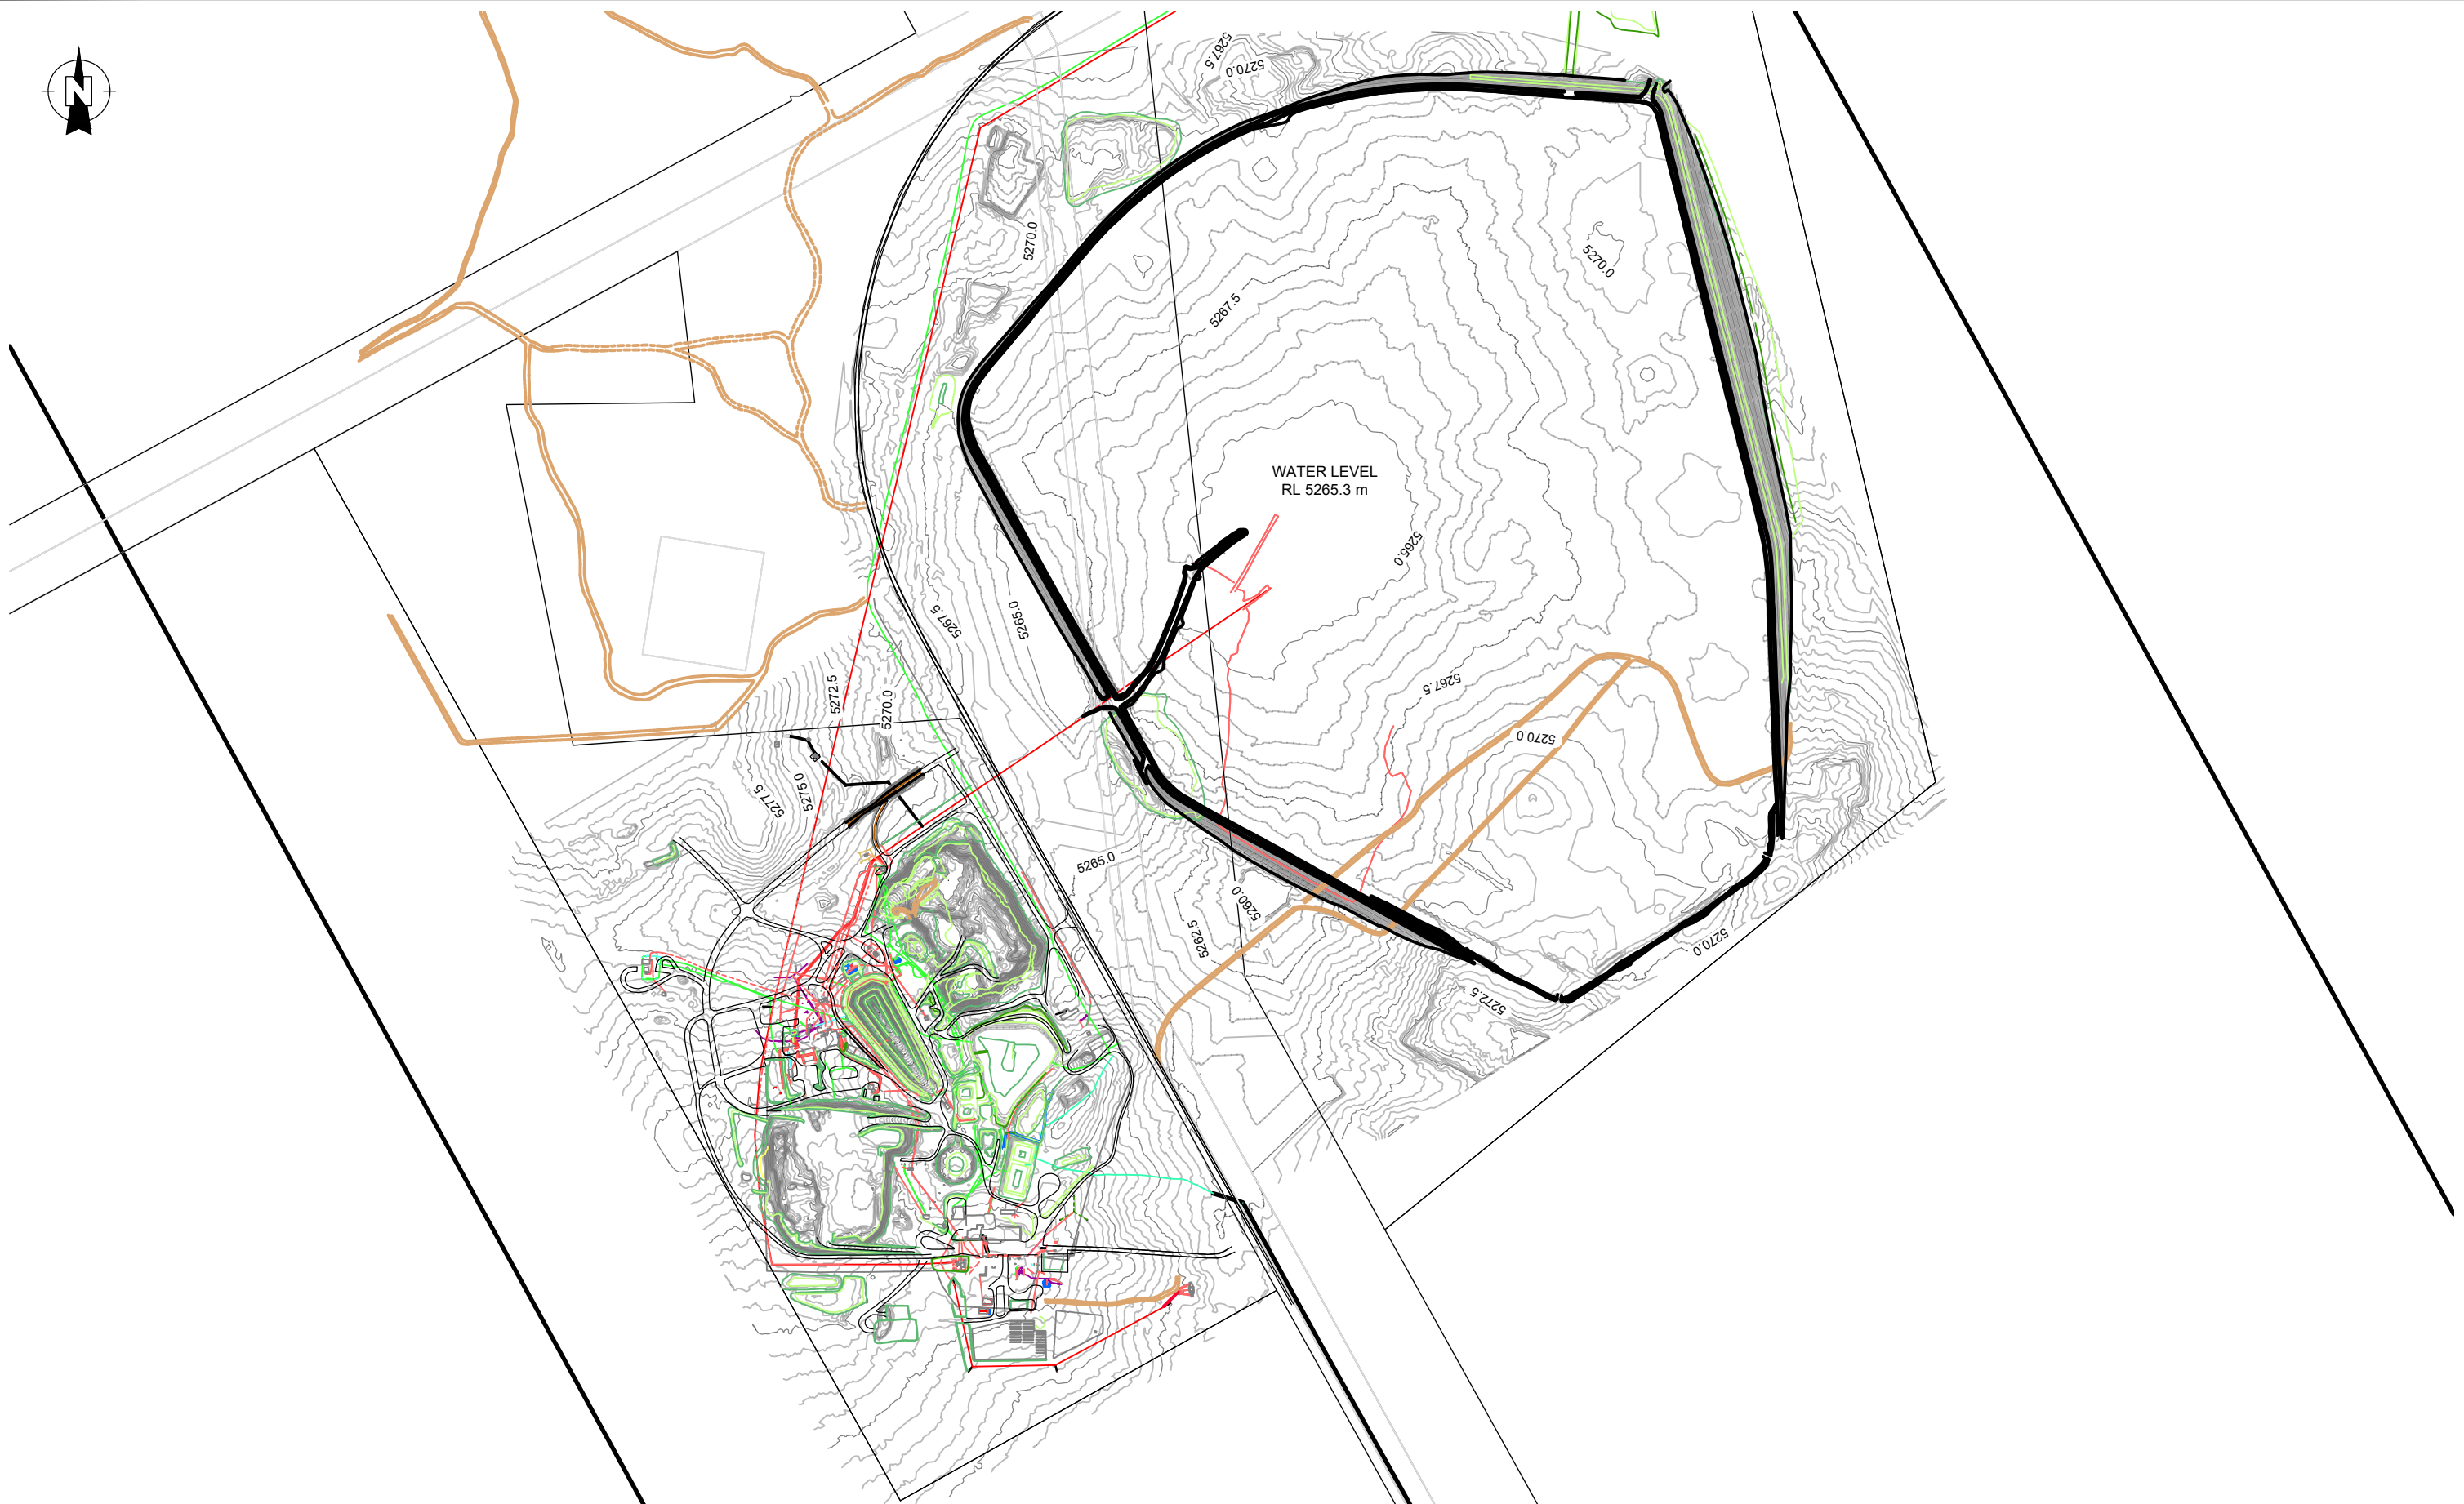
1. CONTOURS GENERATED FROM: Tritton Site TSF Contours 2021.DXF
2. COORDINATE SYSTEM: LOCAL MINE GRID
