## 6. Rehabilitation Implementation

### 6.1 Life Of Mine Rehabilitation Schedule

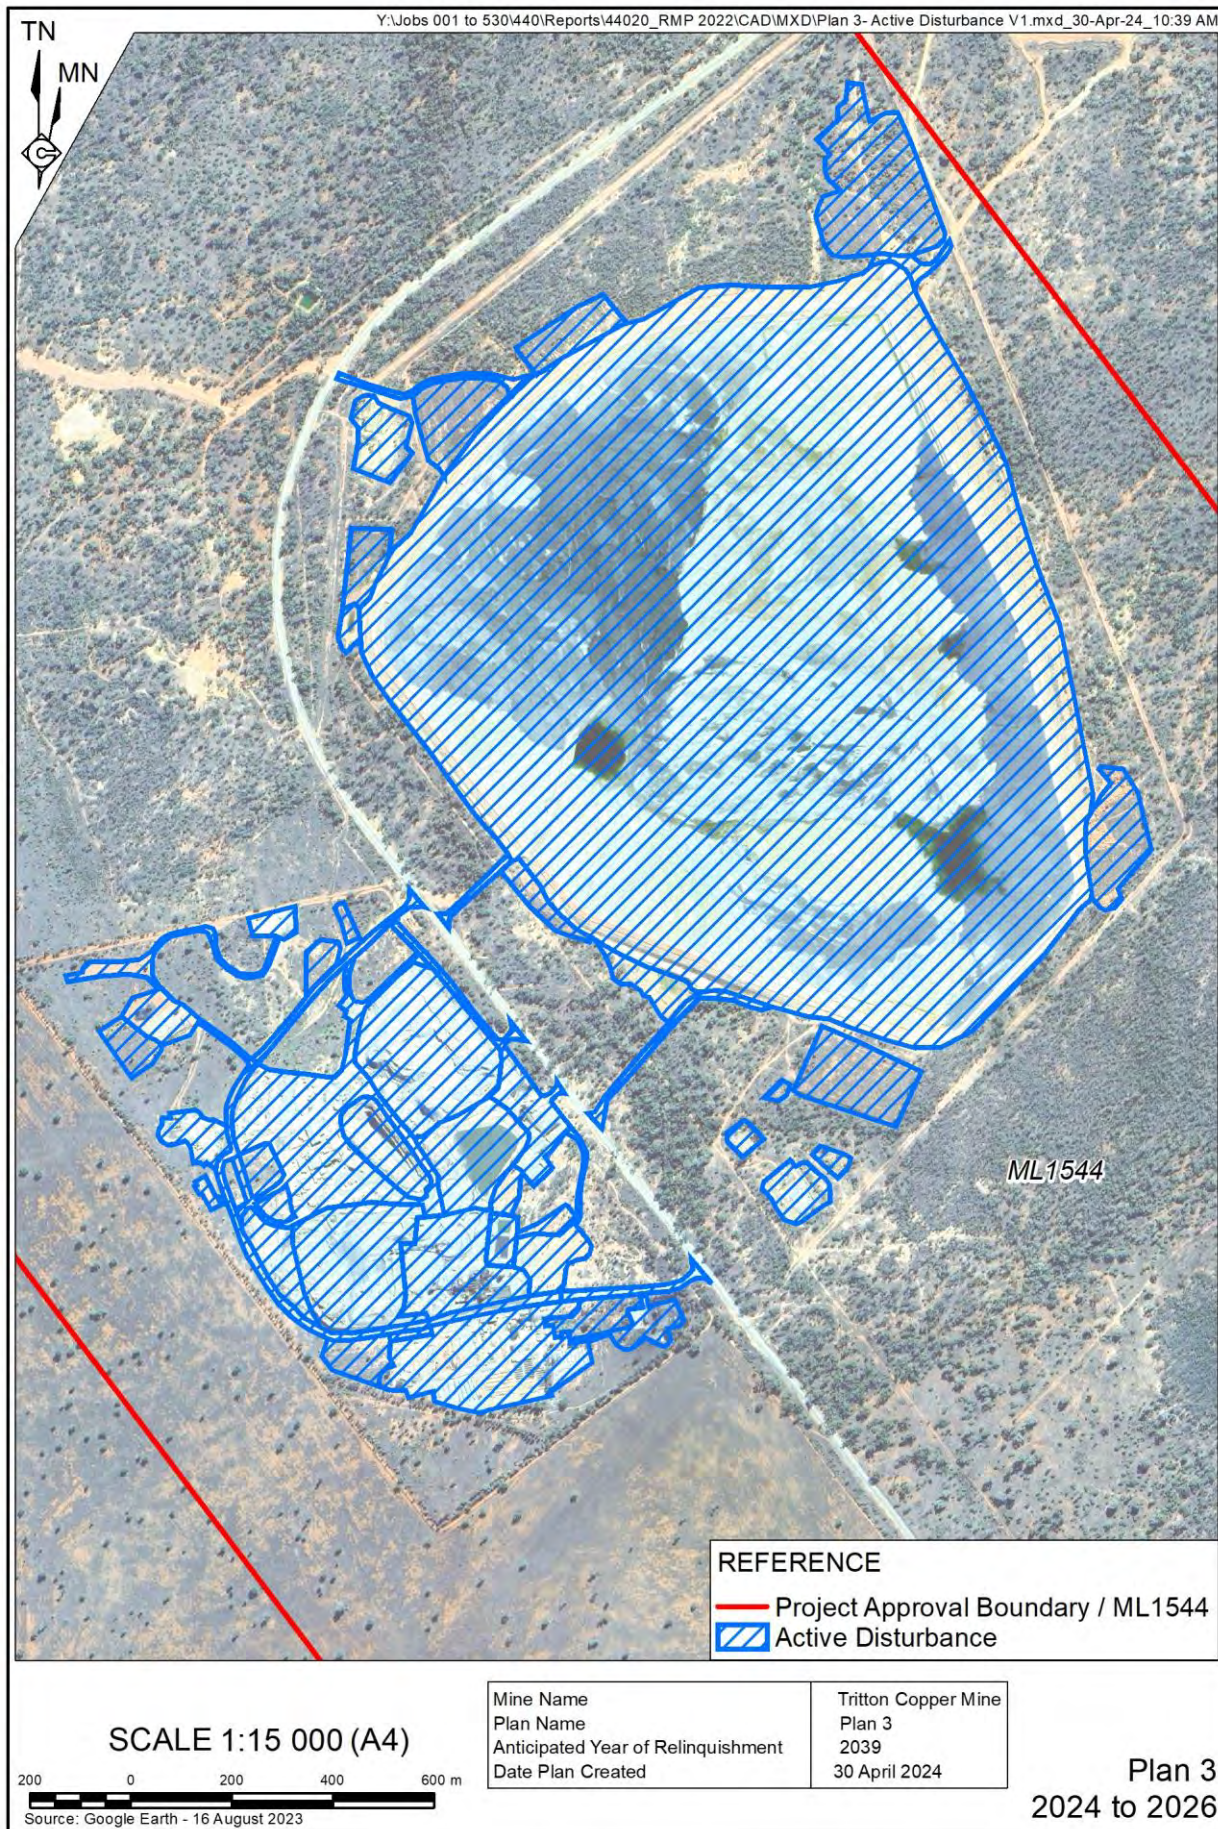
- 2024 to 2026 (**Plan 3**):
  - Revegetation Strategy and Seed Collection and Procurement Strategy prepared
  - Preparation of numerical groundwater model (for all mines within the Tritton Copper Operations) and Post Closure Water Management Plan developed.
  - Land contamination and hazard assessment including remediation plan developed.
  - Tailings Storage Facility progressive rehabilitation and maintenance of batters.
  - Tailings Storage Facility capping concept design research and trials (if required). This may include Landform Evolution Modelling and consolidation assessments, as required.
  - Decommissioning of landfill (depending on remaining capacity).

**Figure 8** depicts the current extent of disturbance at the Mine Site (i.e. the mining domains). **Plans 3 to 5** present the indicative rehabilitation schedule for the Mine Site by depicting those areas which will be rehabilitated during each 5-yearly increment between the commencement of this plan and Mine closure. It is noted that this schedule is applicable only until the completion of the Ecosystem and Land Use Establishment phase of rehabilitation operations within all Mining Domains (see Section 6.2). Approximate timings for the Ecosystem and Land Use Development phase of rehabilitation have not yet been defined as this phase will principally involve the monitoring and maintenance of completed rehabilitation works until completion criteria identified in Section 4.1 have been achieved.

The rehabilitation schedule for the Mine Site is presented on **Plans 3 to 5** and summarised as follows.

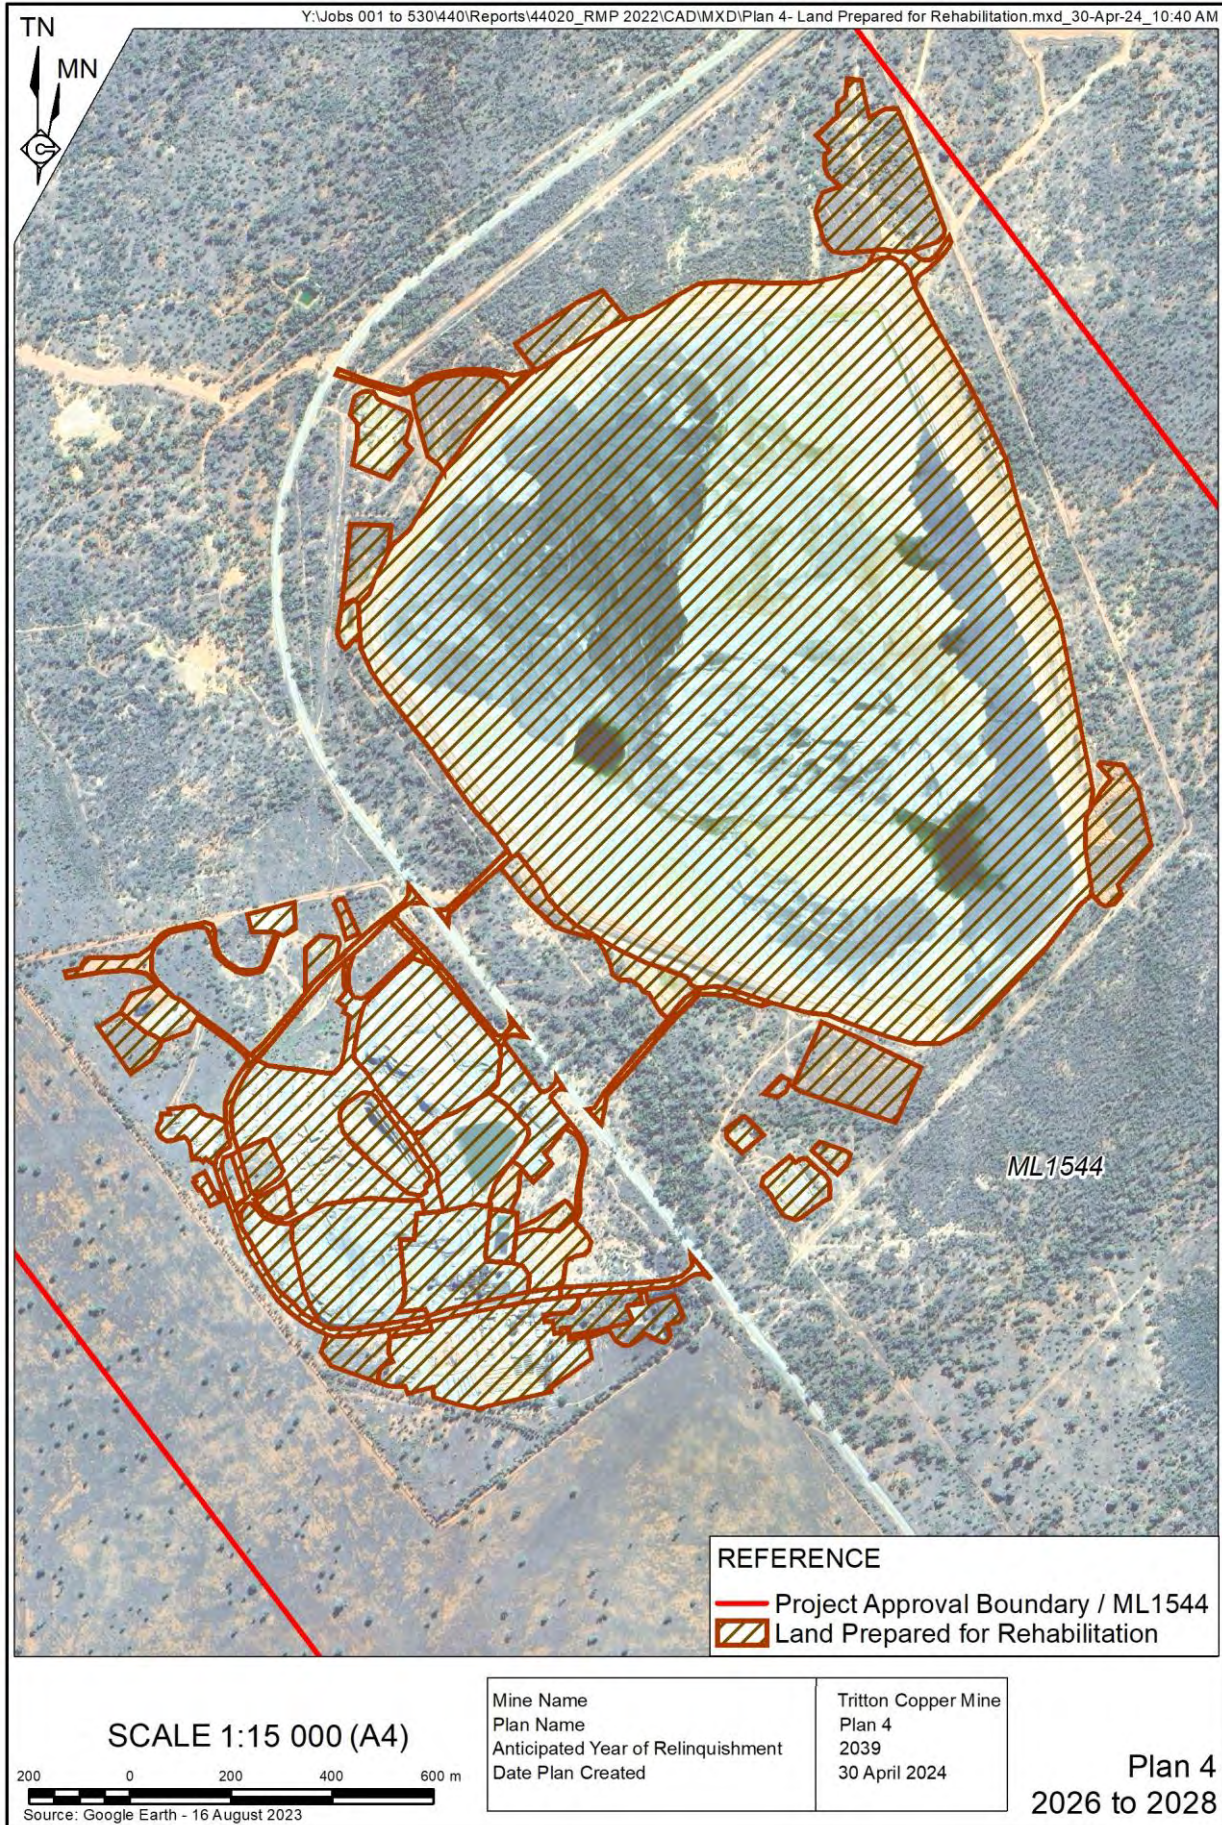
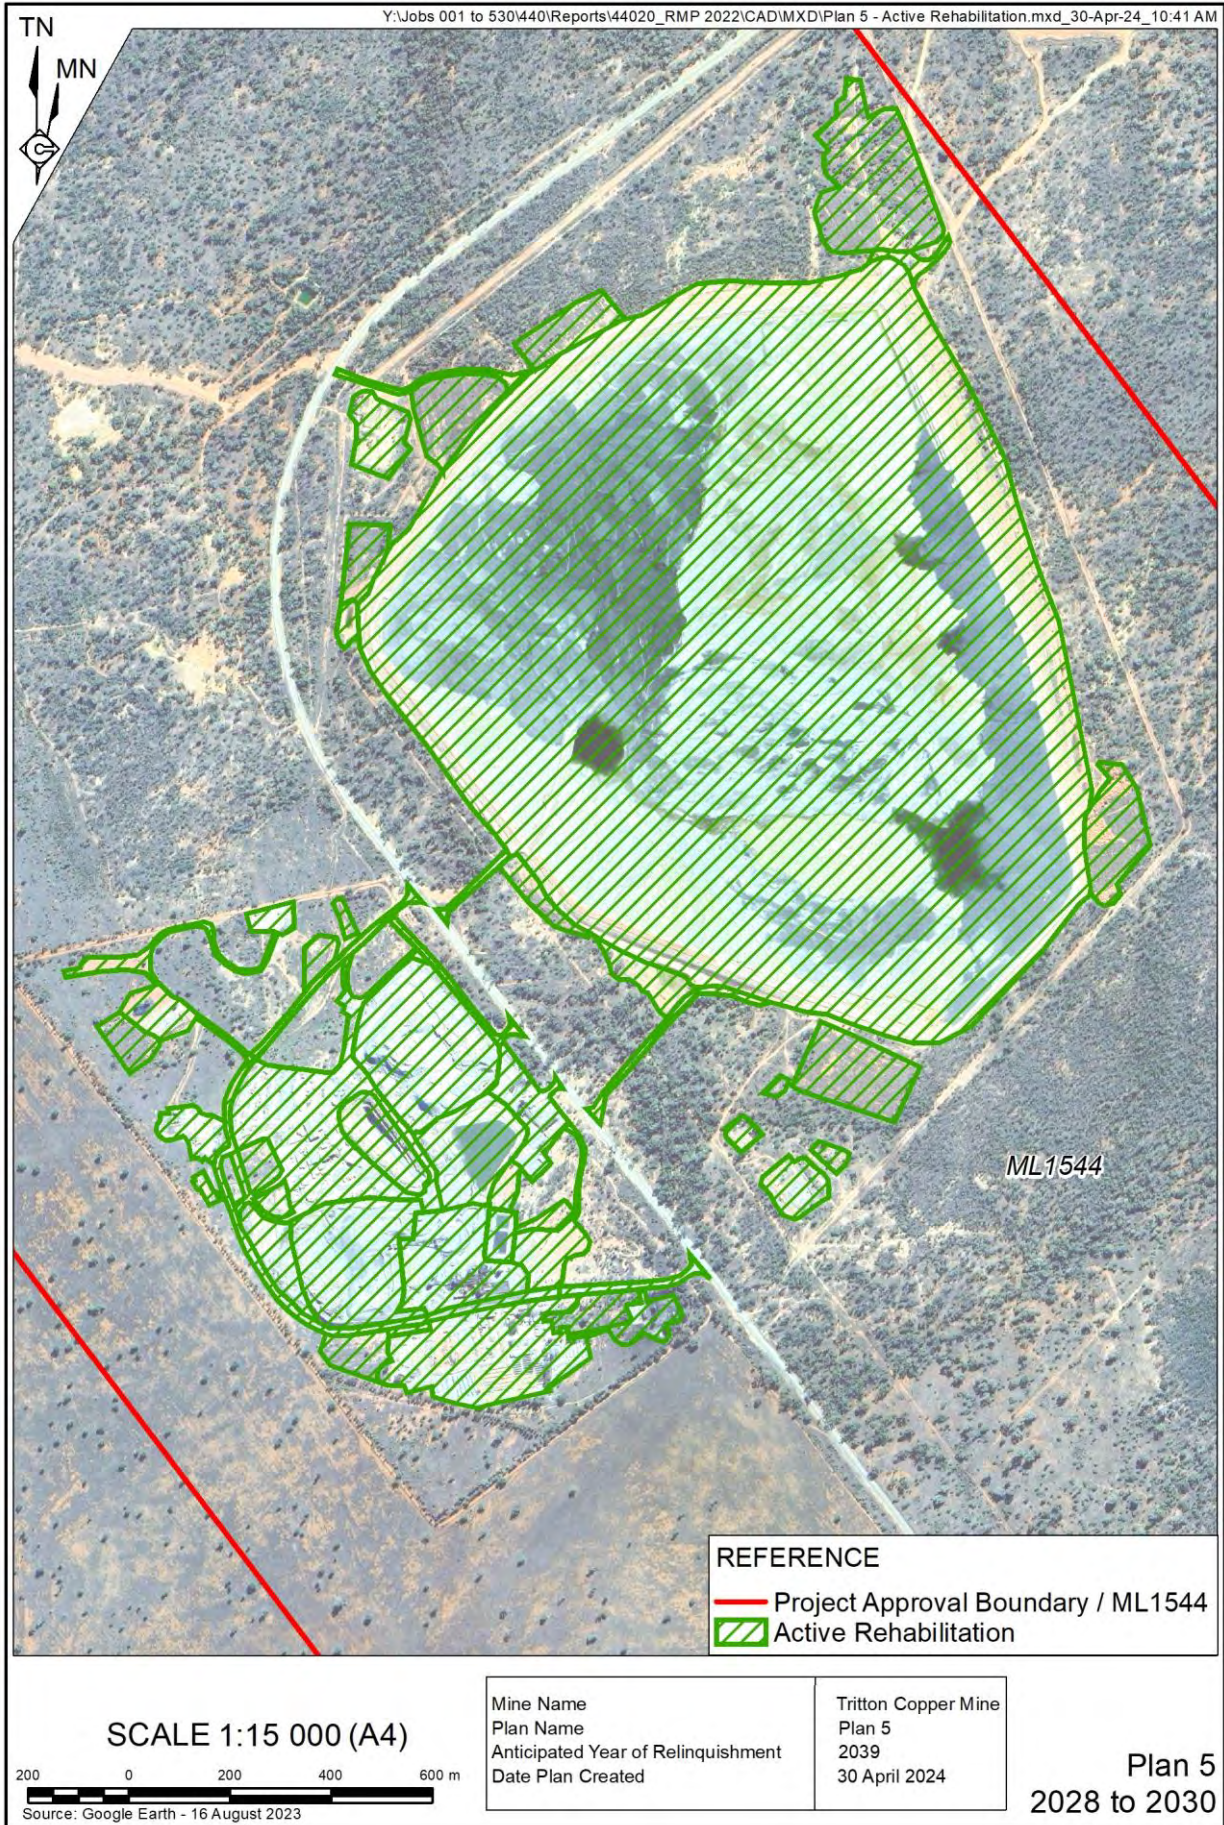
- 2026 to 2030 (**Plan 4 and 5**):
  - Whole of site decommissioning, landform establishment, growth medium development and ecosystem and land use establishment and developments phases of rehabilitation to occur across all mining domains.
  - It is anticipated that the rehabilitation of all mining domains and the successful establishment of all final land use domains (up to the Ecosystem and Land Use Establishment phase, as a minimum) will be completed by 2028 with a further four years of monitoring and maintenance (to 2032).
