2019 Calendar Year Surveillance Review
Tailings Dam 1
Aeris Tritton Mine

Tritton Resources Pty Ltd
PER2019-0430AB rev0

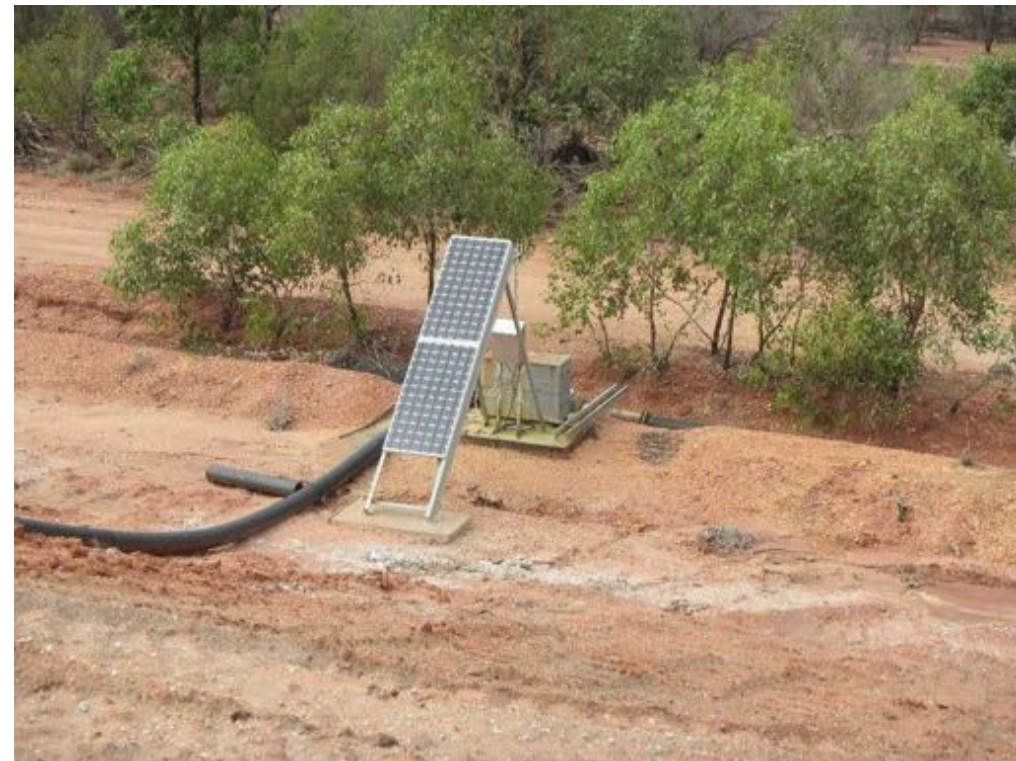
Solar panel for pressure drop trigger.

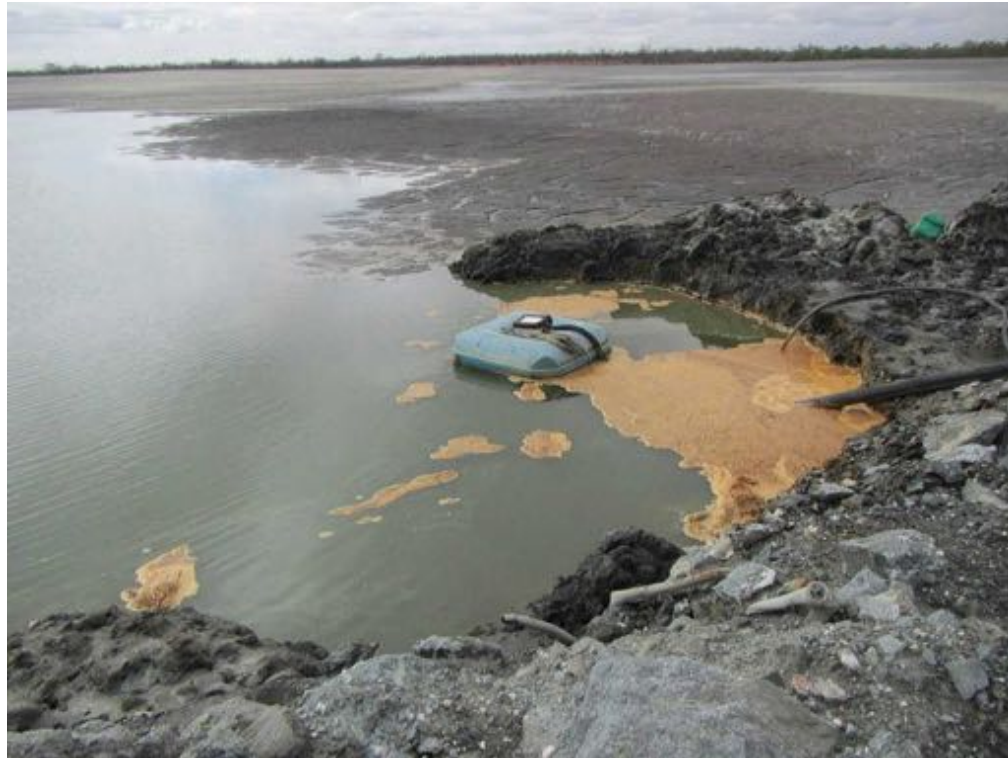
Floating pump south side of causeway.

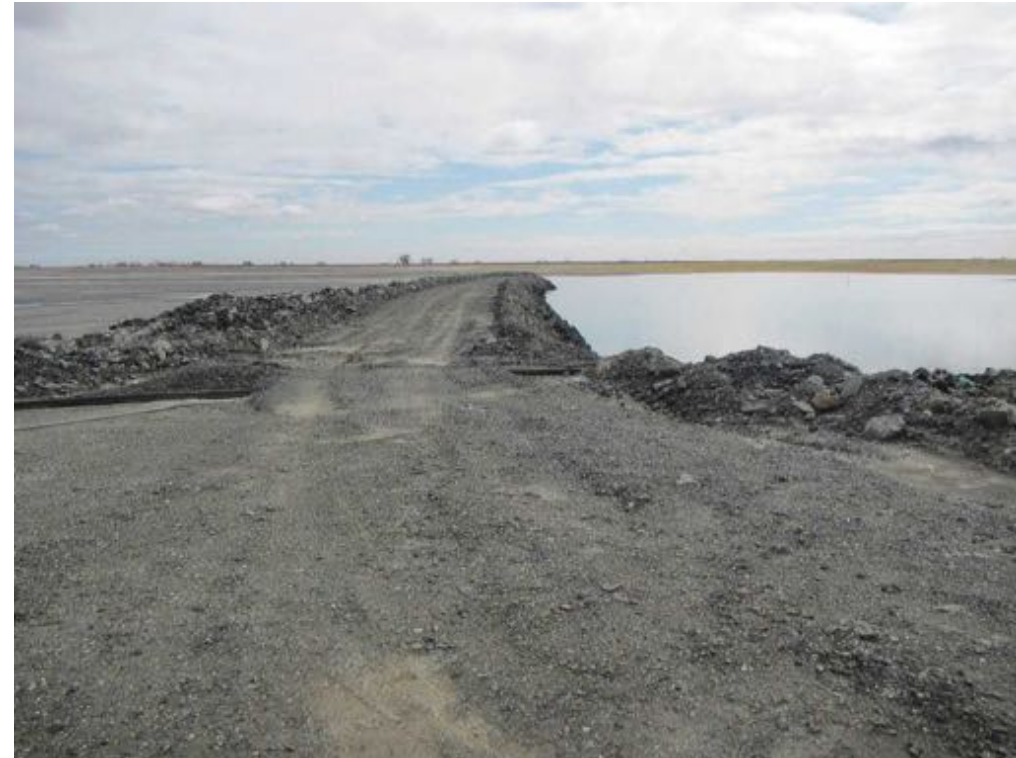
Looking along decant accessway toward water pond.

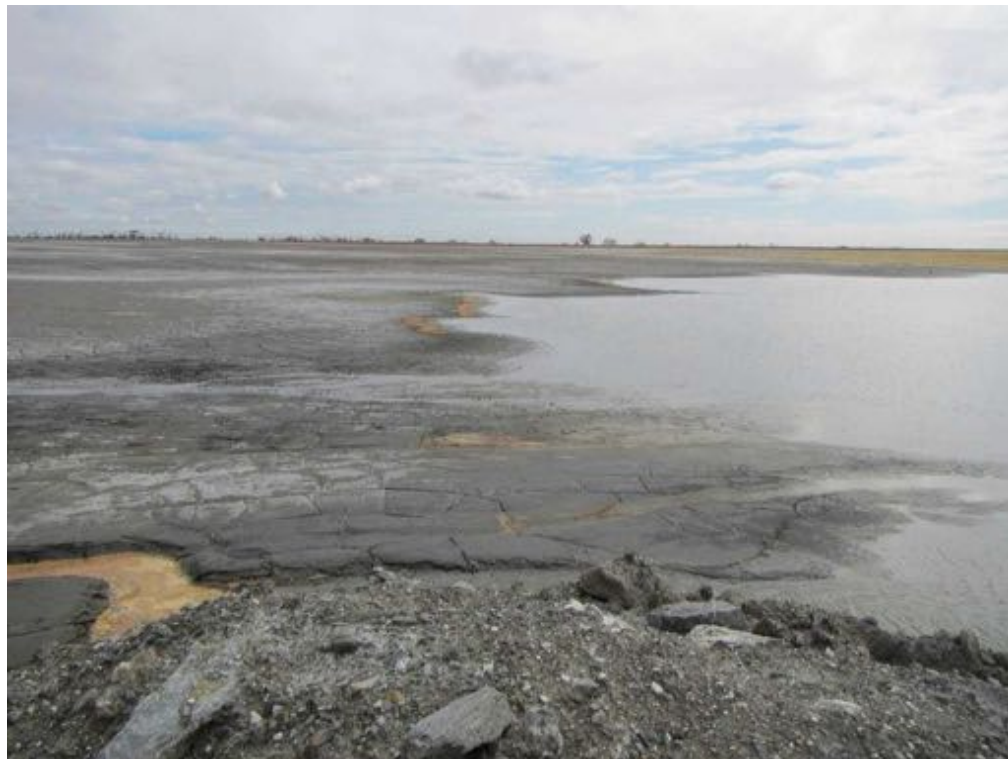
Decant water recovery pond.

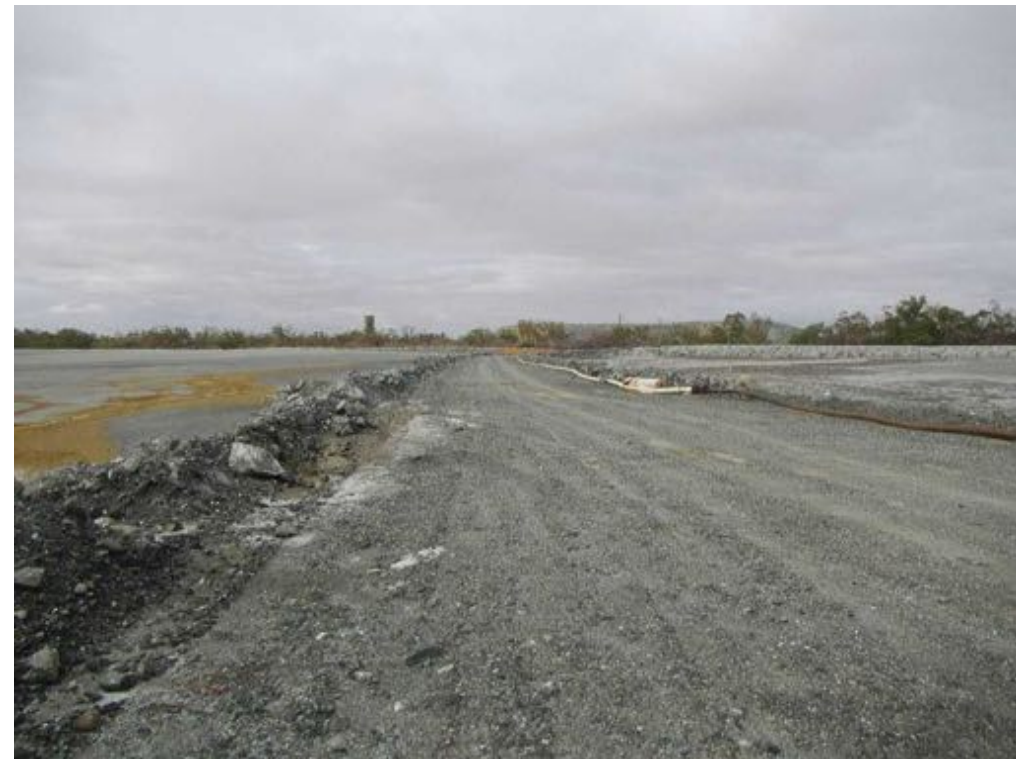
Looking along decant accessway toward western embankment.

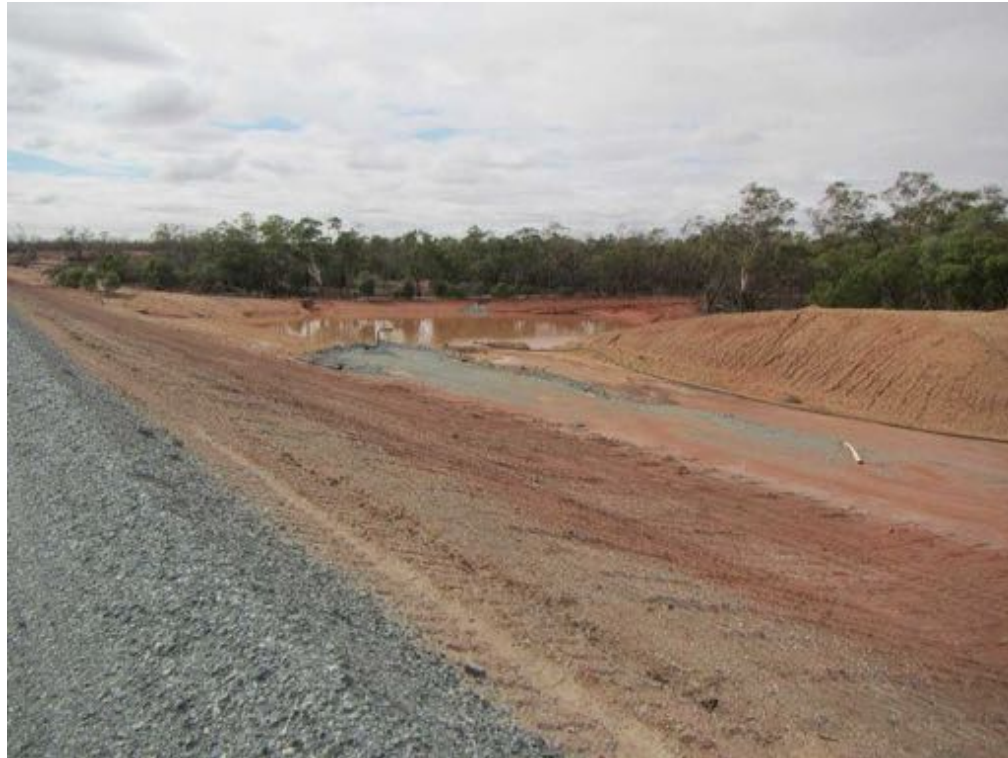
Sump downstream of western embankment.

- Any rainfall runoff collected behind the western saddle embankment should be monitored, the temporary use of this area as a source of construction water is considered acceptable in the short term. The embankment crest should be monitored (visually) for any signs of distress in the way of cracking or slumping. Of note the mine has placed a berm along the downstream toe to prevent water ponding against the original embankment toe.

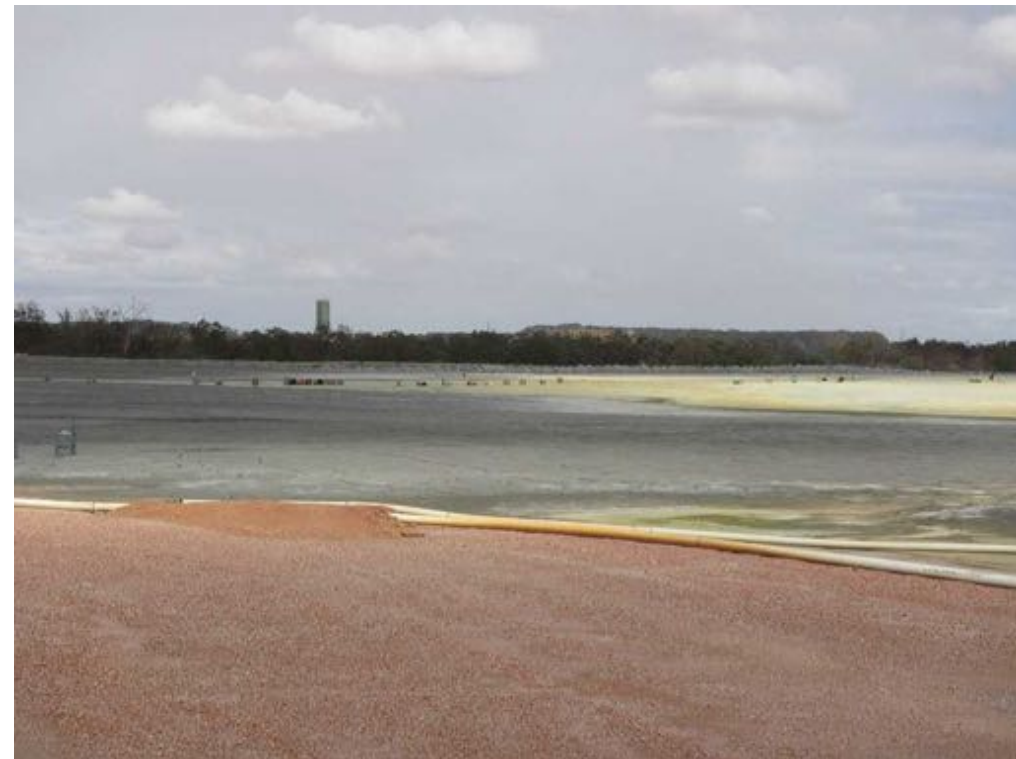
General view over tailings dam looking north north-west.
